Assessment of 895 Trees  
at  
The Hills at Vallco Project  
North Wolfe Road  
Cupertino, California

Prepared for:  
Vallco Property Owner LLC  
c/o Mr. Reed Moulds  
Sand Hill Property Co.  
2882 Sand Hill Road, Suite 241  
Menlo Park, CA 94025

10/5/2015, Revised 10/30/2015

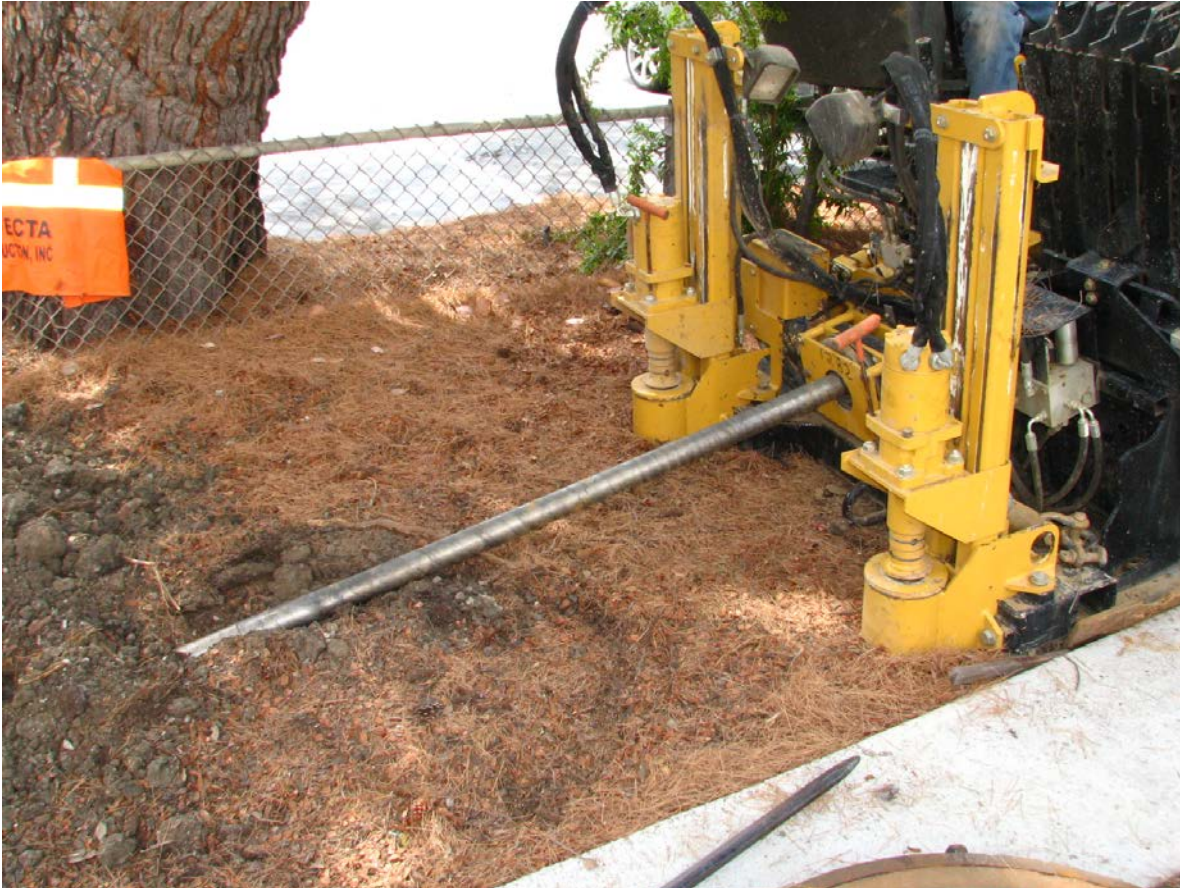
almost complete root preservation when done correctly. See image of pit to pit directional bore in action below on one of my projects in the Bay Area. In this particular case, the bore started above ground, and ended at a pit. Typical method would be to start and end at a small dug pit.

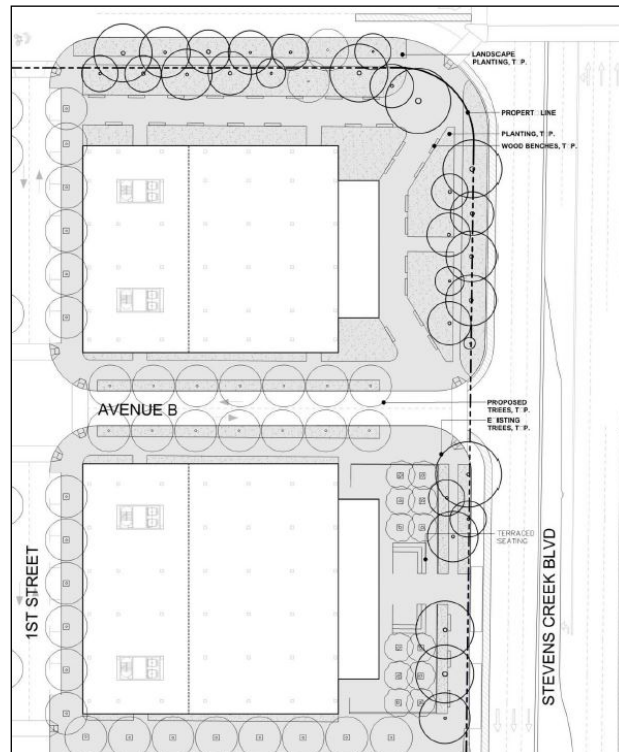
Some of the trees such as those circles drawn along the hard black line property boundary that rings the site are shamel ash specimens being retained, while other trees drawn on this sheet by the landscape architect are proposed new “in-fill” trees to augment existing screening.

WLCA's main concern in areas such as this involves demolition crew activities during removal of surface hardscape and deep curbs, which may be comingled with existing woody tree root systems. When pulling out the curbs and hardscape piece by piece, these roots may become tangled with the machinery bucket teeth and be pulled, ripped, or otherwise destroyed or damaged in the process. Therefore, an arborist monitor is suggested during demolition of any material within approximately 20 feet of a tree to be retained. As noted above in this report, we know that woody tree roots can extend laterally as far as 3x to 5x the canopy dripline distance from the trunk edge, which means that a 20 foot radius canopy tree may theoretically have roots extending as far as 60 to 100 feet radius out from trunk, even under asphalt, if there are no physical impediments to growth extension such as deep curbs or deep foundation footings.

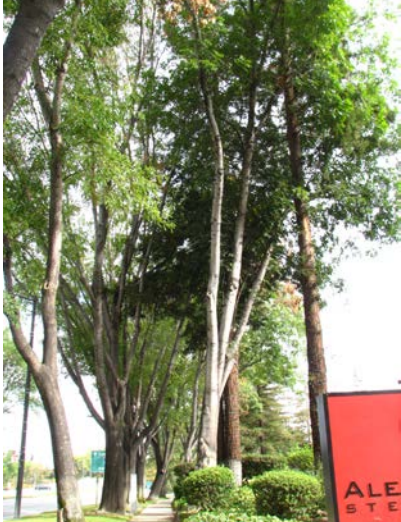
<p>426 to 444 along west side of Alexander's Steakhouse</p> <p>Some of these trees are to remain, and others are suggested by WLCA to be removed due to safety (risk) concerns</p>

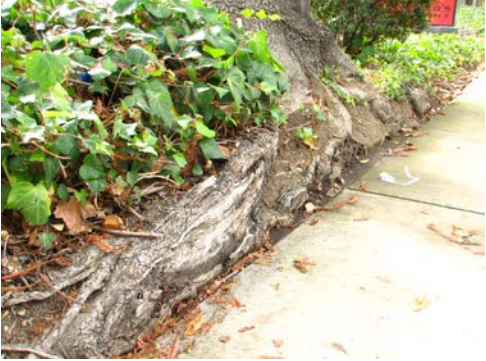
<p>Close-up of the roots severed along the west side of tree 438, (suggested by WLCA to be removed), during sidewalk replacement.</p>

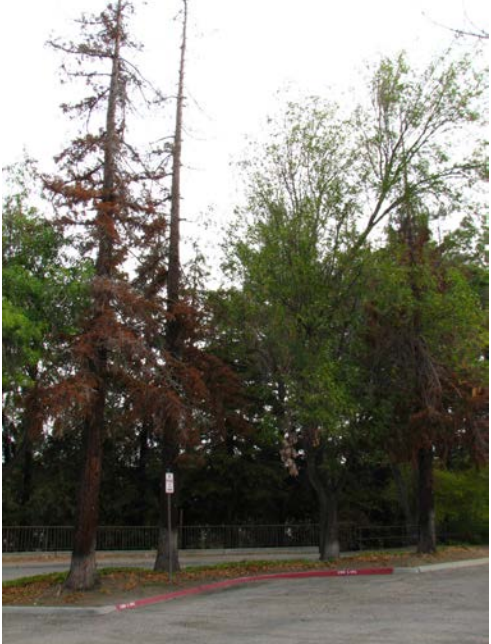
<p>Example of redwoods and ash specimens 332, 333, and 335 in very poor condition due to soil moisture deficit, at the JC Penny parking lot.</p>

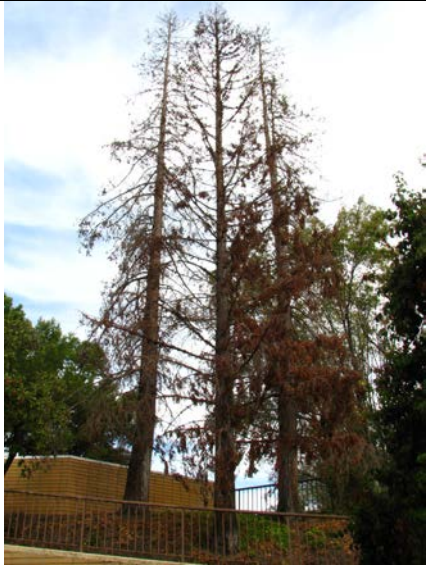
<p>Redwoods 500, 501, and 502 are dead in the southeast corner of the JC Penny parking lot area. These trees are planned to be removed.</p>

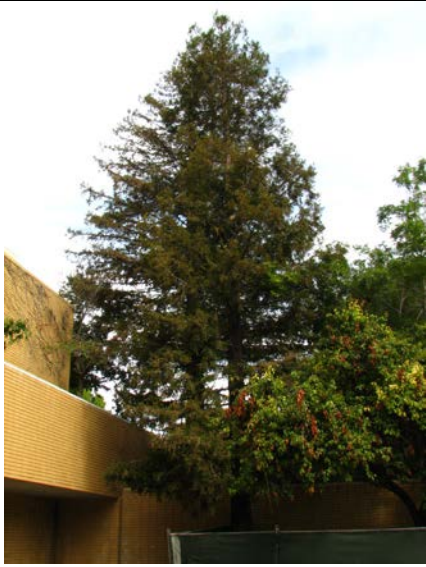
<p>In contrast to dead redwoods 500, 501, and 502 shown in the image at left, redwoods 505 and 510 at right are in decent condition just 30 or 40 feet west. The trees are to be removed.</p>

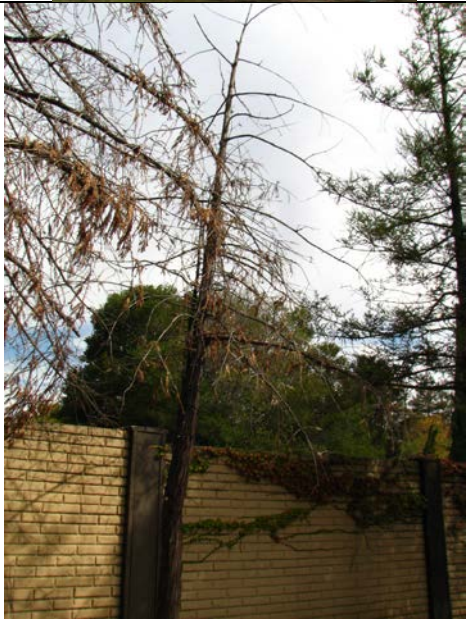
<p>Redwood specimens along the west side of west perimeter road are suffering severely from soil moisture deficit, and are generally declining or dying</p>

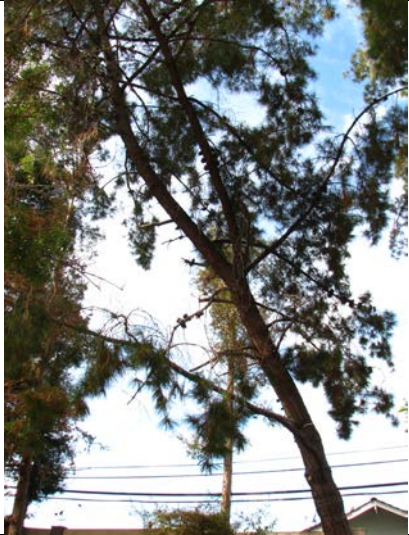
Tree #	Image	Tree #	Image
<p>Monterey pine 726 rates out with a probable risk of failure due to lean, girdling roots, etc. This tree is in WLCA's suggested removal list.</p>

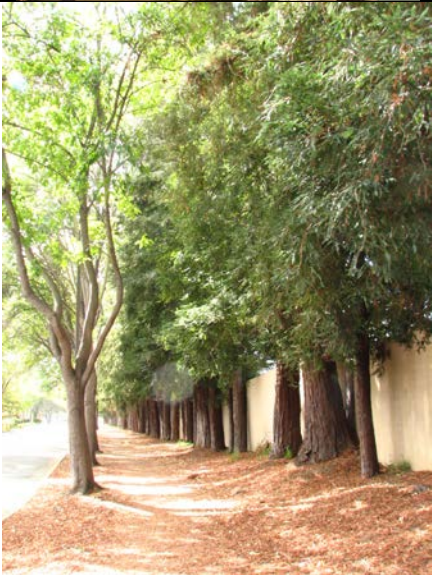
<p>The dense screen along the west side of west perimeter road as shown here near tree 771 is in danger of dying due to soil moisture deficit. Replacement of these high water use trees with drought tolerant evergreen species is a viable option.</p>

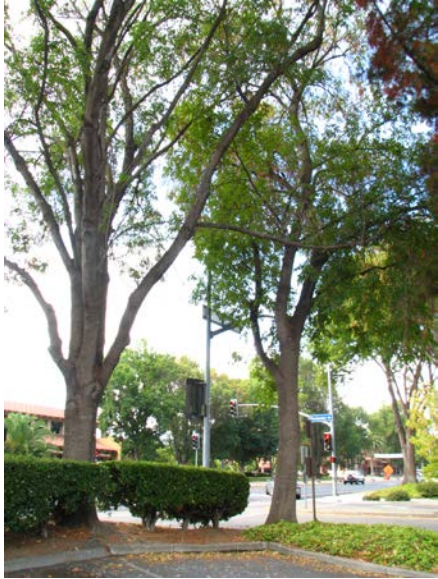
Tree #	Image	Tree #	Image
<p>Shamel ash trees 8 and 9 to be retained at the southwest corner of the Vallco site.</p> <p>Note curb and asphalt displacement from root growth. If this hardscape is removed and replaced, severe root loss and root damage may result, ending in further tree decline or death.</p>

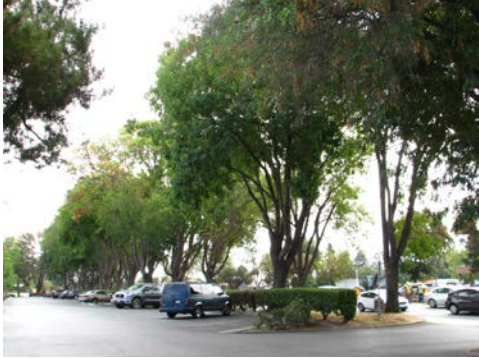
<p>Shamel ash 9 to 36 to be retained along this south border of the site, looking east. Again, removal of or alternation of existing curb and asphalt materials could cause severe root damage to these already drought-stressed specimens, resulting in further tree decline or death.</p>
<p>Shamel ash 23 to 36 to be retained, looking southeast.</p>

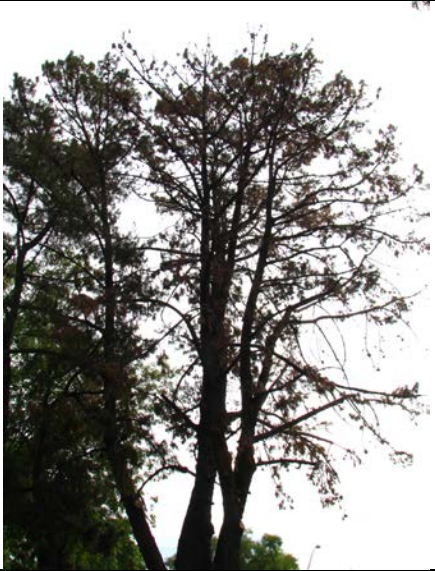
Tree #	Image	Tree #	Image
<p>Monterey pine 51 at southeast corner of the Vallco site. This tree is dead, and needs to be removed at this time as a high risk of failure and impact to targets.</p>

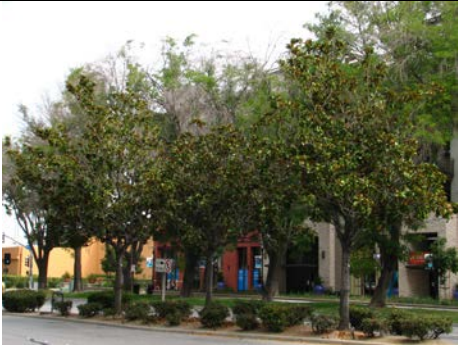
<p>Southern magnolias 1106, 1107, 1108 proposed by the project team to be retained, are in decline due to severe soil moisture deficit, and may need to be removed.</p>
