# Cupertino City Hall Alternates Study Structural Evaluation:

10300 Torre Avenue, Cupertino, CA 95014-3202

Tipping Mar  
1906 Shattuck Avenue  
Berkeley, CA 94704  
510.549.1906 tel | 510.549.1912 fax  
TM Job No. 2014,094.00

**September 29, 2014**

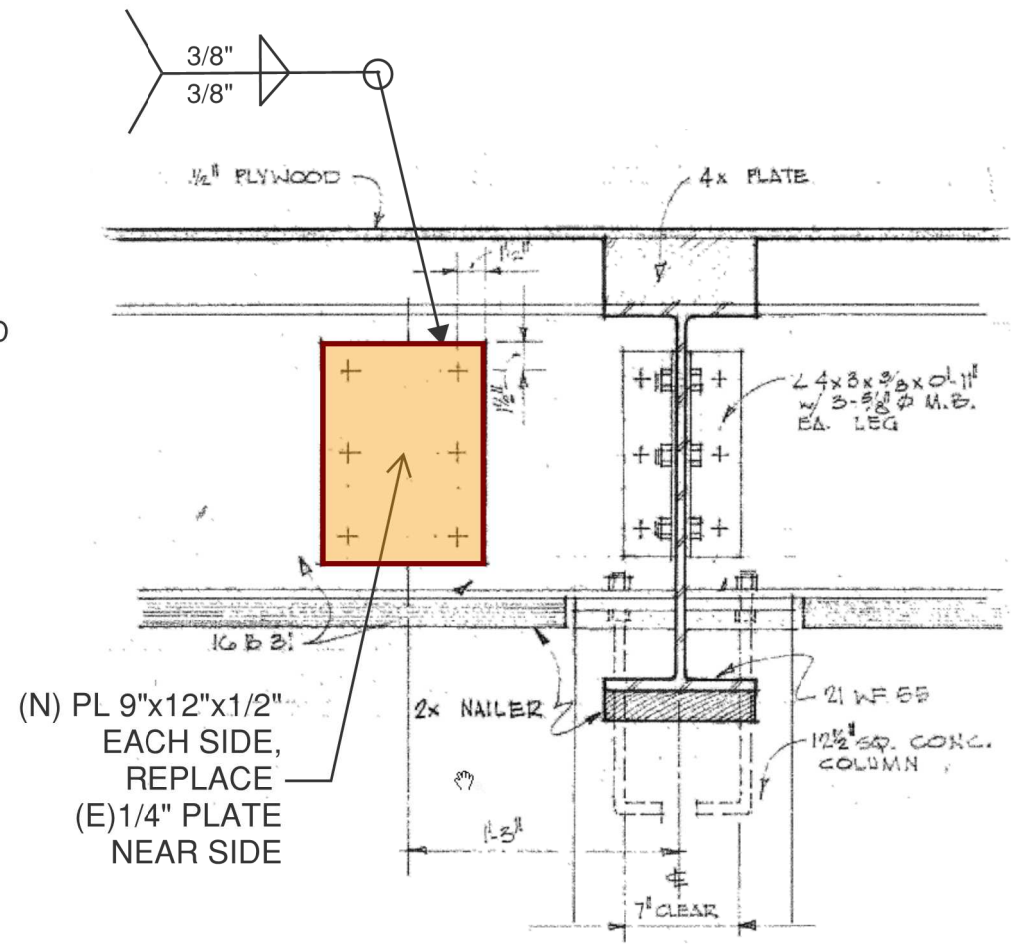
DETAIL 2 - STEEL TO STEEL COLLECTOR SPLICE

There are several types of collector connections at the roof level, all of which require strengthening to increase their load carrying capacity. Where the existing roof diaphragm collectors are wide flange steel roof beams, they are currently spliced to each other with machine bolts. These splices will need to be strengthened with additional new splice plates and new welding as shown in on Sheet S3, Detail 2, of the attached building retrofit drawings. Where existing roof collectors occur at steel wide flange to wood girder locations, additional horizontal Simpson Holdowns or CMST straps are required to strengthen the existing steel beam to timber girder connections, as shown in Detail 1 of Sheet S3. The porch colonnade on the exterior perimeter of the building is constructed of concrete beams and columns. The anchorage connections between these

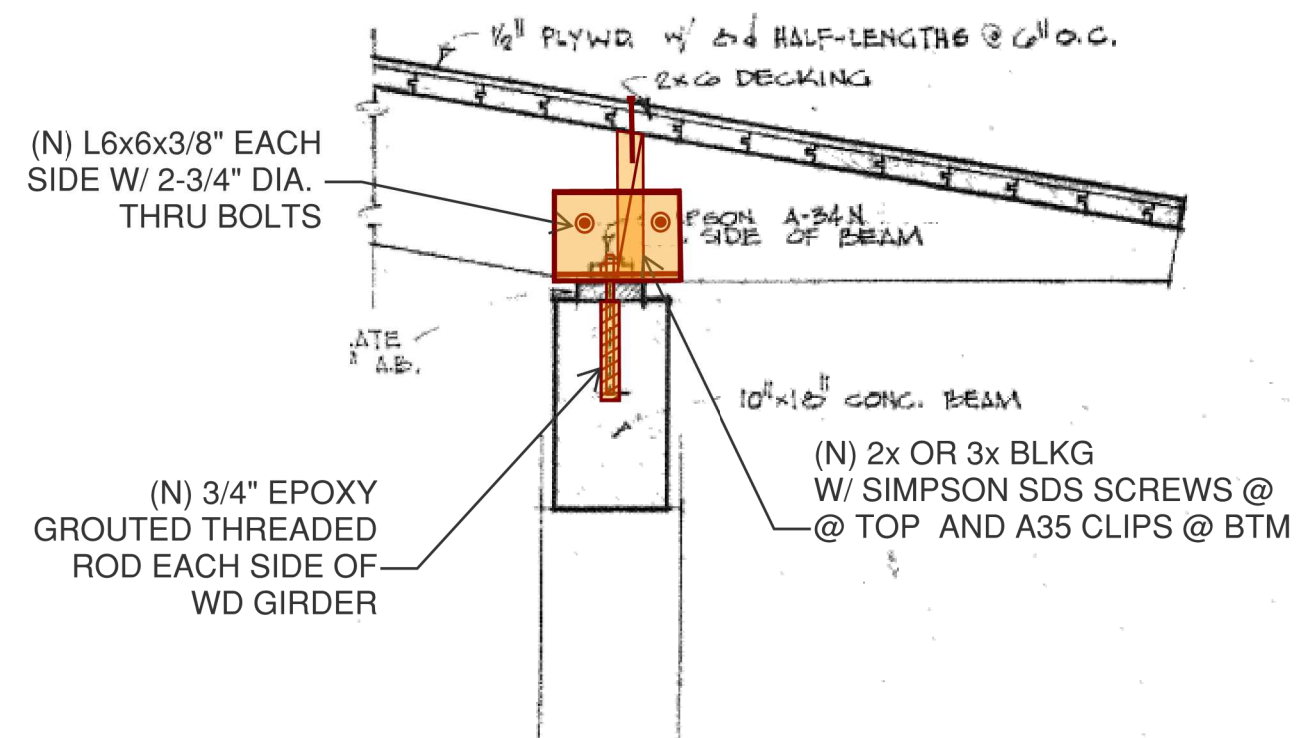
DETAIL 4 - COLONNADE TO ROOF ANCHORAGE

beams/columns and the wood roof framing and diaphragm currently lacks a clear load path and does not have adequate capacity. New connecting members should be installed to provide proper anchorage between the colonnade and the roof diaphragm, as shown in Detail 4 of Sheet S3. Finally, the collector connections anchoring the steel beams to the tops of the existing concrete shear walls need to be strengthened. Additional anchor bolts will be added between existing shear walls and collectors. New shear walls will also be connected to the existing steel roof beam collectors with new anchor bolts.
