Assessment of 995 Trees at Vallco Town Center Project (Proposed) North Wolfe Road Cupertino, California

Walter Levison, Consulting Arborist (WLCA)

10/5/2015 Revised 8/20/2018

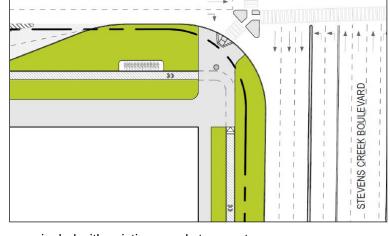
Demolition of existing curbs, planting areas, asphalt parking stall surface materials, etc. to make way for new landscaping may cause significant or severe damage to the below ground portions of trees being retained such as shamel ash at the southwest end of the site along the south boundary of the former Sears parking lot (see sample blowup at right, showing proposed planting plan, street level, sheet P-0605, January, 2018 iteration).

of surface hardscape and deep curbs, which may be comingled with existing woody tree root systems. When pulling out the curbs and hardscape piece by piece, these roots may become tangled with the machinery bucket teeth and be pulled, ripped, or otherwise destroyed or damaged in the process. Therefore, an arborist monitor is suggested during demolition of any material within approximately 20 feet of a tree to be retained. As noted above in this report, we know that woody tree roots can extend laterally as far as 3x to 5x the canopy dripline distance from the trunk edge, which means that a 20 foot radius canopy tree may theoretically have roots extending as far as 60 to 100 feet radius out from trunk, even under asphalt, if there are no physical impediments to growth extension such as deep curbs or deep foundation footings.
