ARBORIST REPORT

HYATT HOUSE HOTEL AT VALLCO PARK

WOLFE ROAD & INTERSTATE 280
CUPERTINO, CALIFORNIA
(APN 316-20-092)

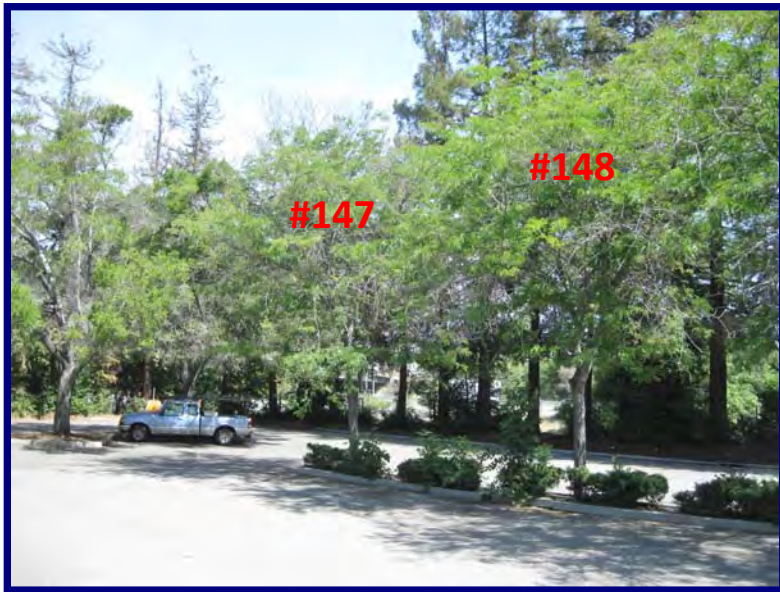
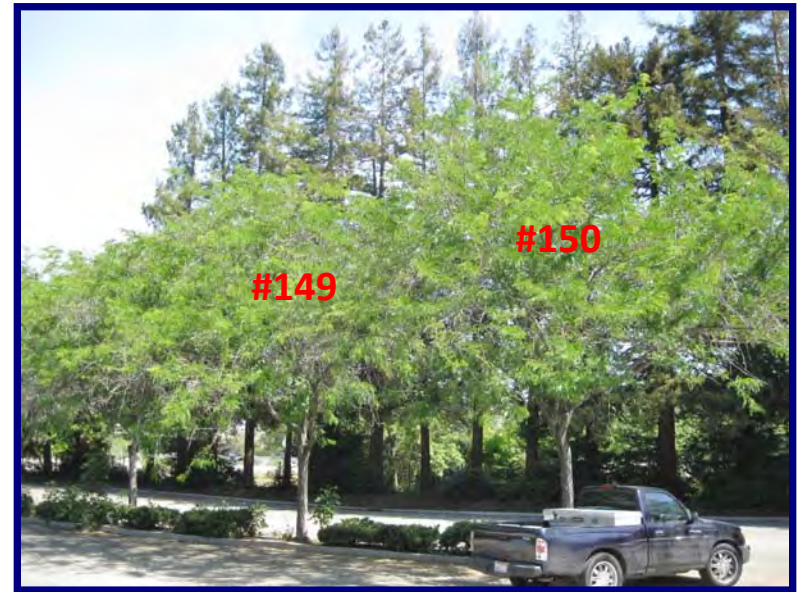
Page C-11: Trees #147 thru 150

146	coast live oak (<i>Quercus agrifolia</i>)	17	40%	30%	Poor	Low	X
Comments: Sparse canopy with excessive limb weight. Poor structure.							
147	honey locust (<i>Gleditsia triacanthos</i>)	10	30%	40%	Poor	Low	X
Comments: Roots have formed mounds in lot and raised adjacent curb. Very sparse canopy.							
148	honey locust (<i>Gleditsia triacanthos</i>)	8	40%	50%	Poor	Low	X
Comments: Adjacent curb has been damaged. Sparse canopy.
