PHASE I ENVIRONMENTAL SITE  
ASSESSMENT FOR VALLCO  
FASHION MALL (2006)

**PHASE I  
ENVIRONMENTAL SITE ASSESSMENT  
UPDATE**

Vallco Fashion Mall  
10123 North Wolfe Road  
Cupertino, California

Project CA 1537-1

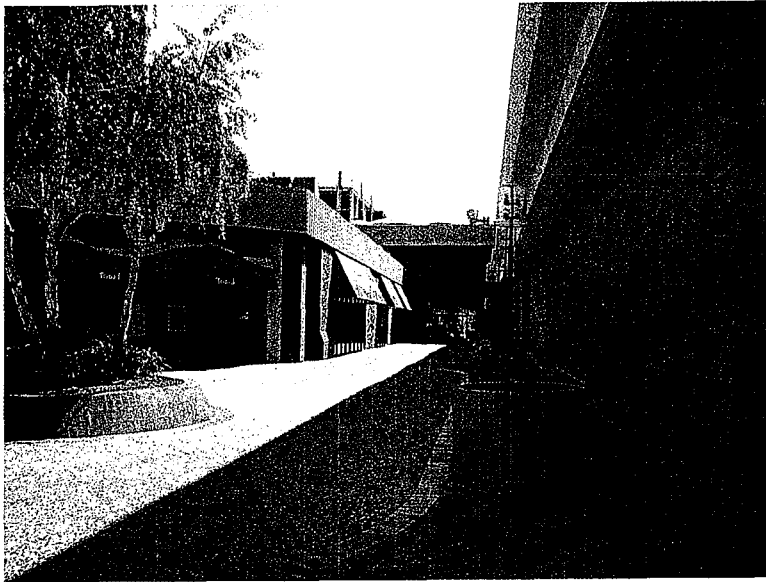
Photograph 1 - View of the west side building entrance, looking east.

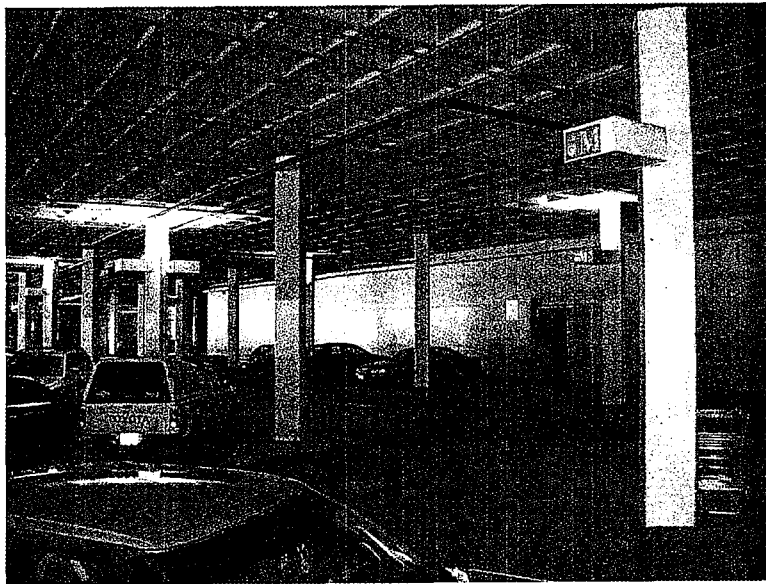
Photograph 2 - view of parking garage.

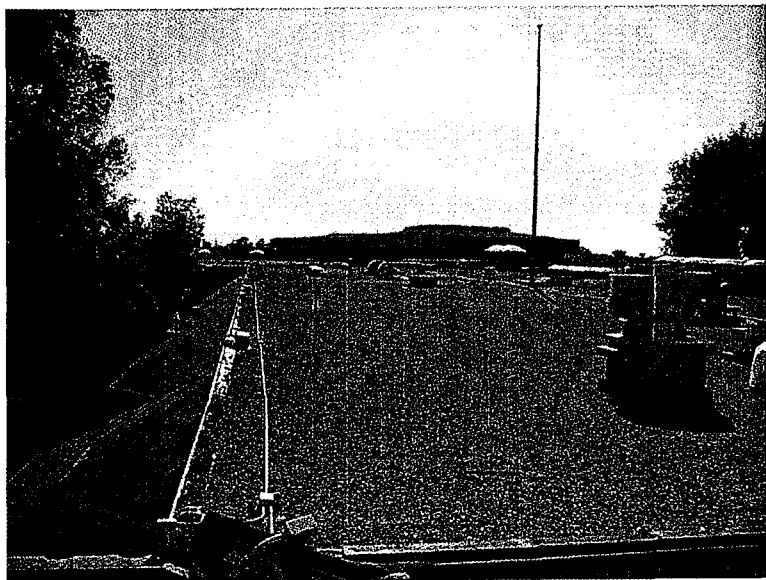
Photograph 3 - View of roof.

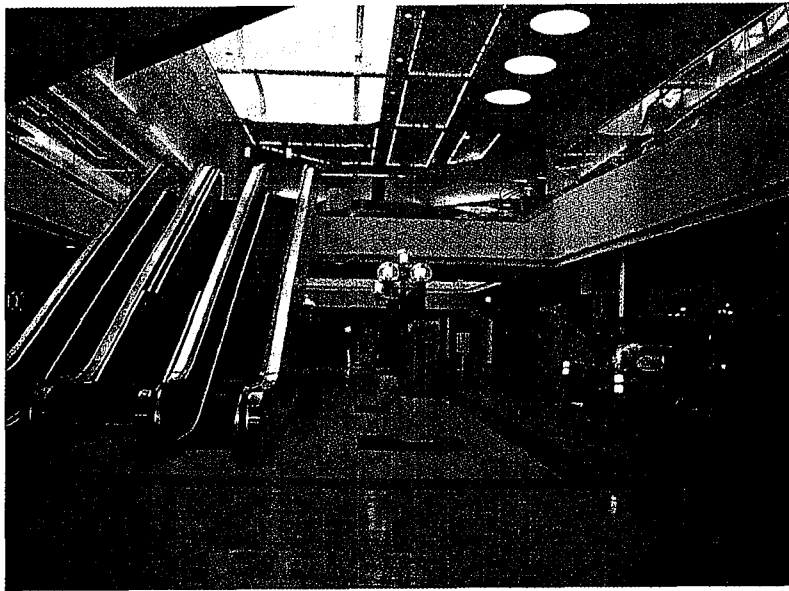
Photograph 4 - View of lower level.

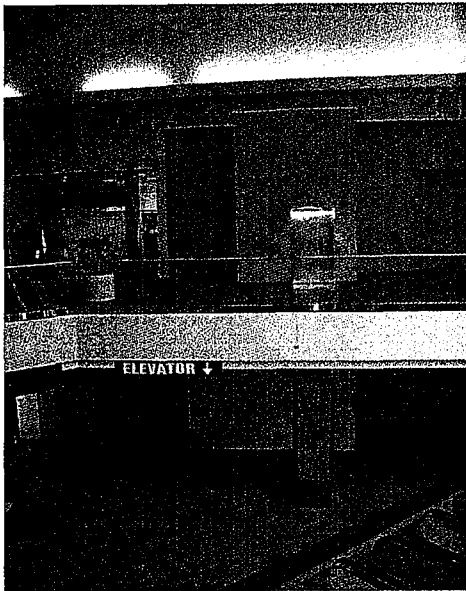
According to Mr. Goodwin, the motors for the elevators and escalators contain hydraulic fluid and grease. They are maintained weekly by Kone USA, an outside company. Leaks or staining was not observed in the vicinity of the elevators or escalators.

Photograph 5 - View of elevator.

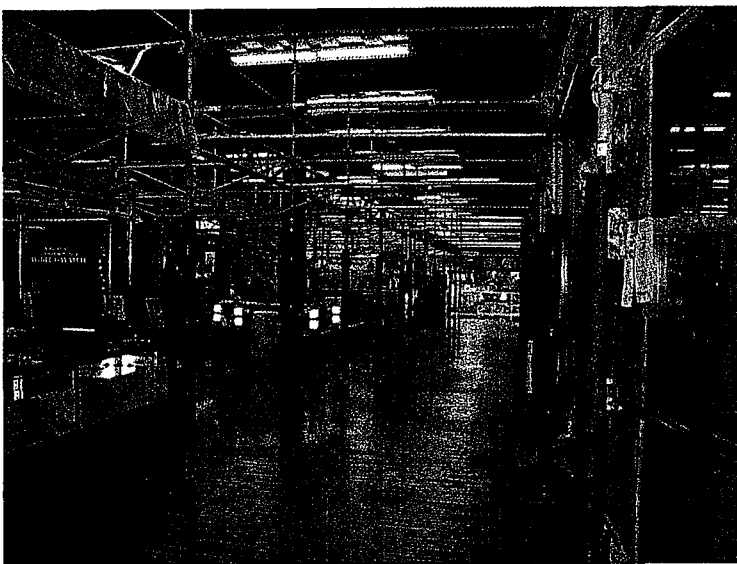
Photograph 6 - View of scaffolding in second level.

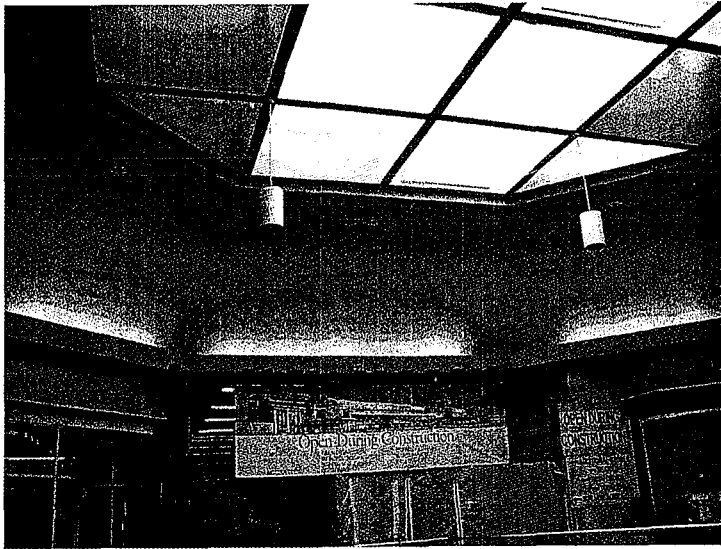
Photograph 7 - View of typical skylight.

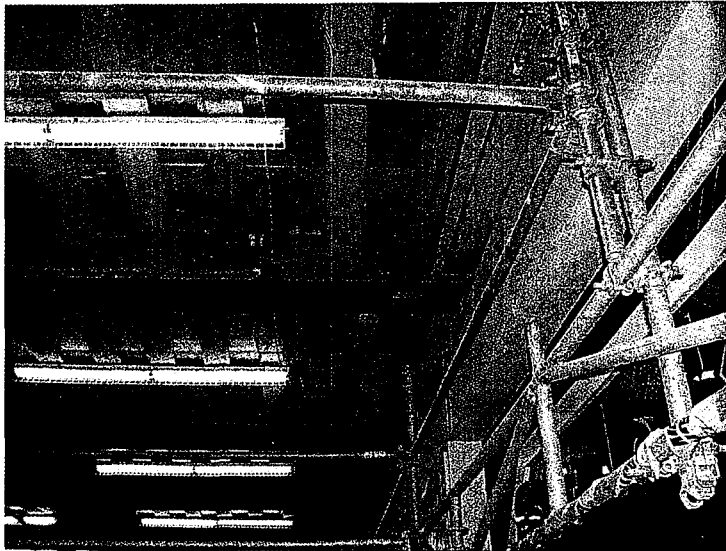
Photograph 8 - View of exposed infrastructure.

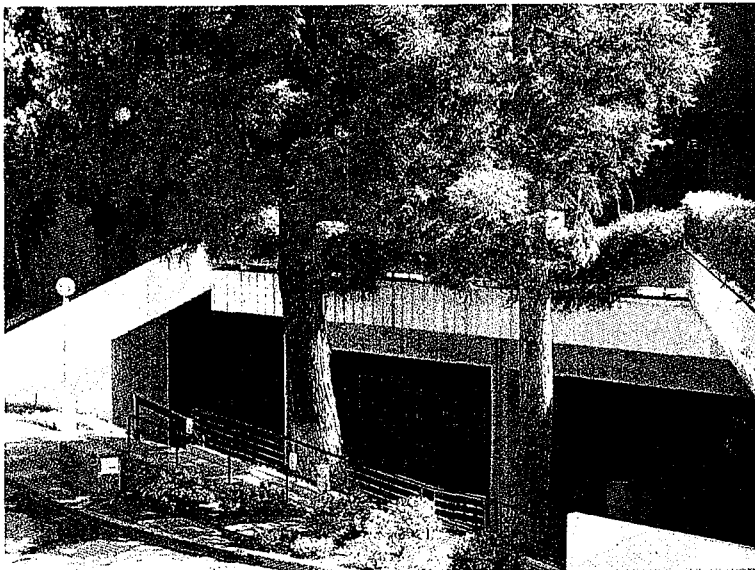
Photograph 9 - view of north side entrance.

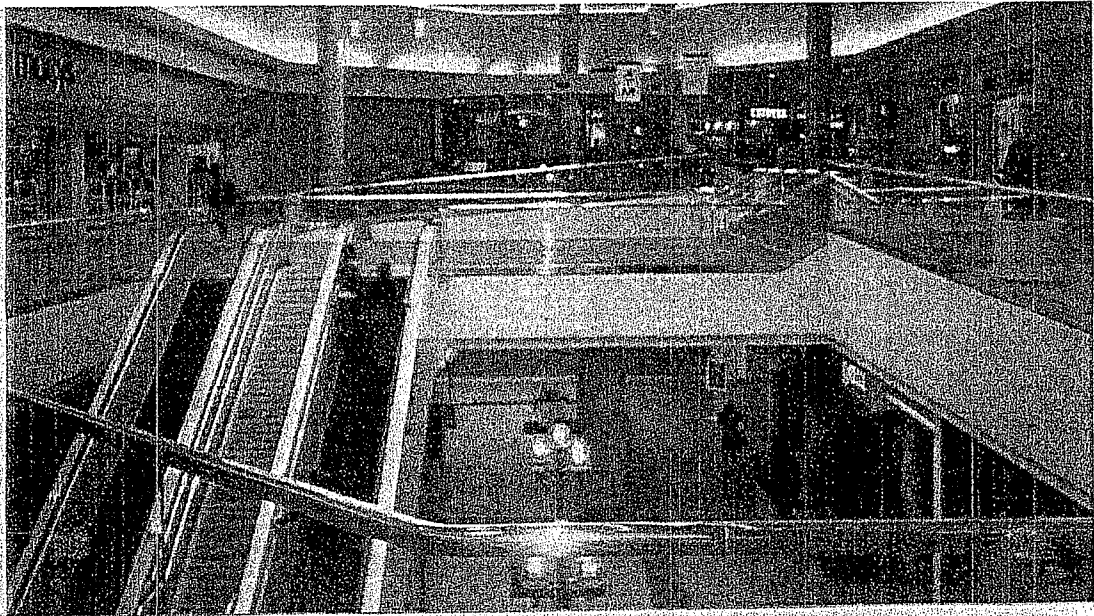
Photograph 1: Interior view of the shopping mall.

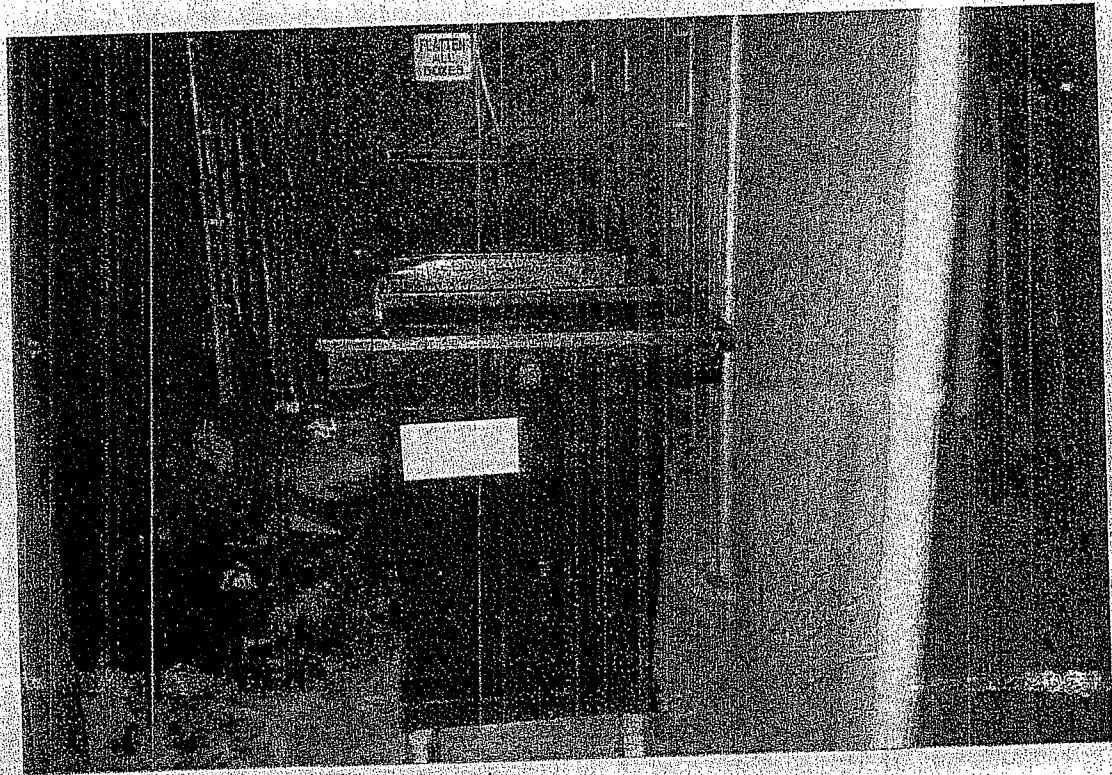
Photograph 2: View of a kitchen grease container.

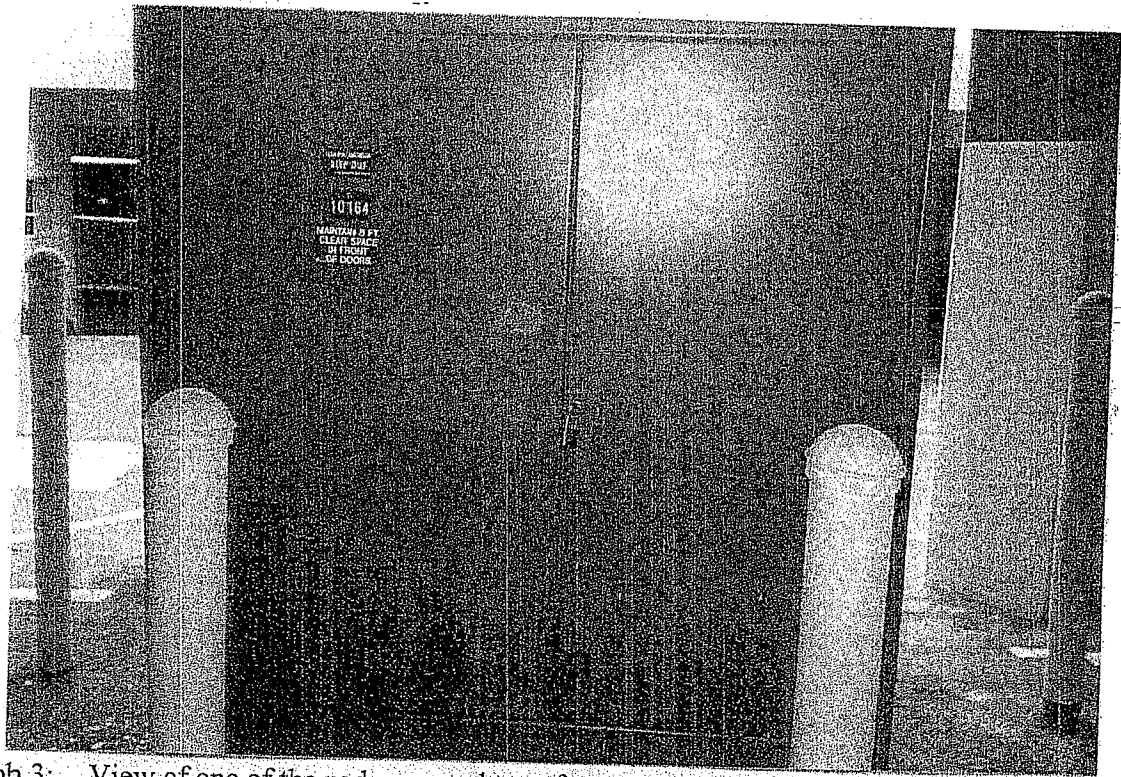
Eight pad-mounted transformers are present on the Property. Pacific Gas & Electric (PG&E) has indicated to Ceres Associates that PCBs were removed from transformers in the area in the late 1970's and early 1980's. Leaks or stains were not observed on or around the transformers.

Photograph 3: View of one of the pad-mounted transformers on the Property.

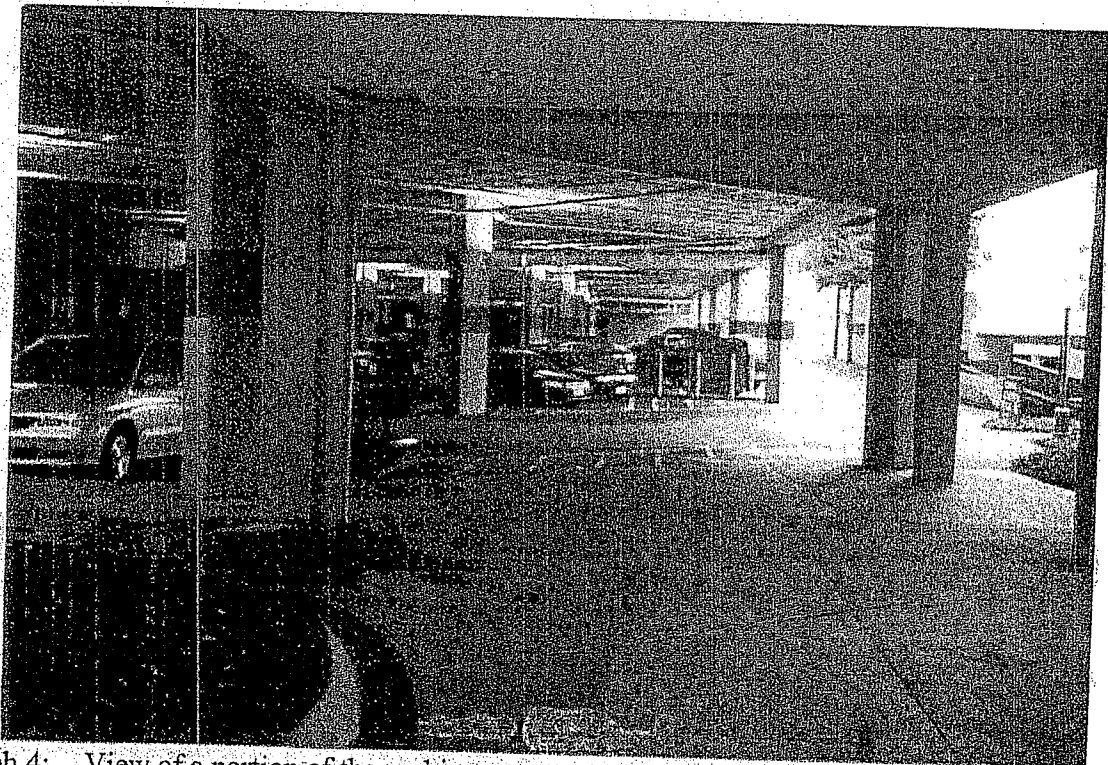
Photograph 4: View of a portion of the parking garage.

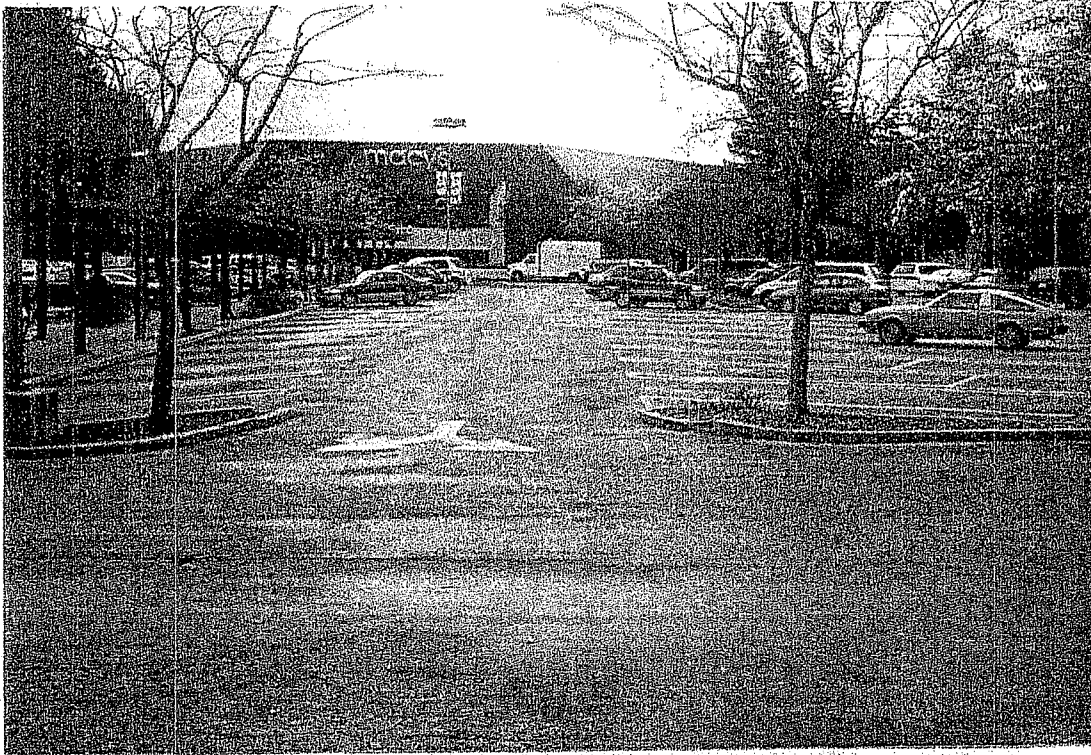
Photograph 5: View of the parking lot on the northwestern portion of the Property - photo facing south.

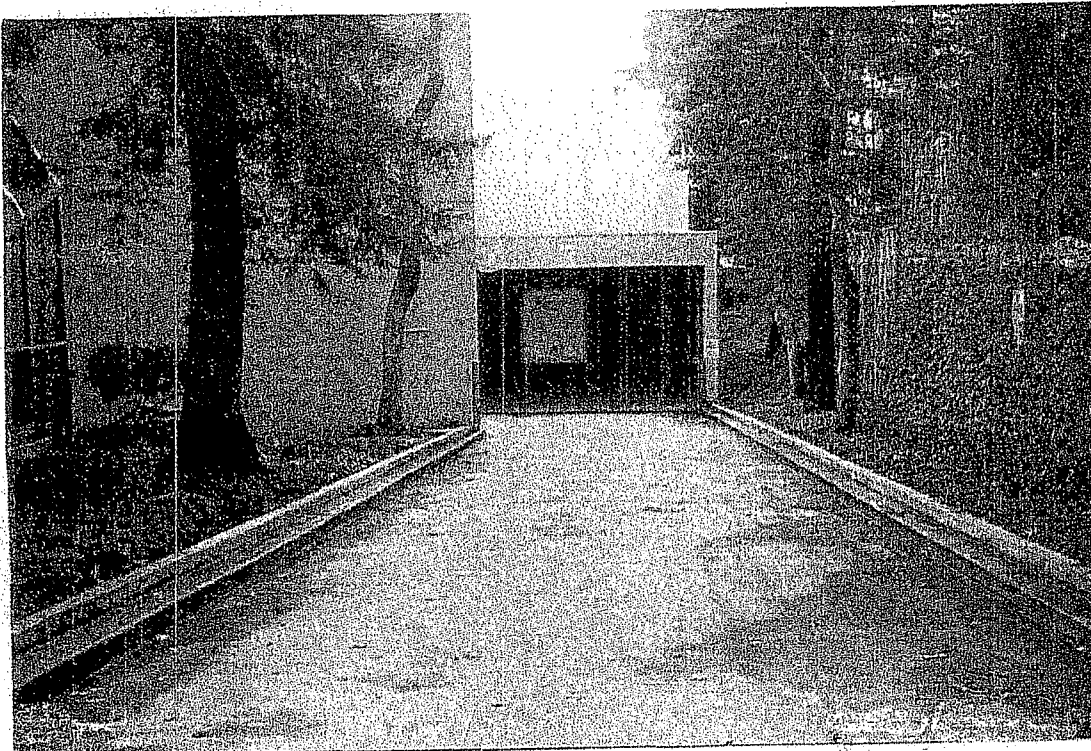
Photograph 6: View of the below grade loading dock adjacent to the west side of Macy's.
