Vallco Town Center Specific Plan

Environmental Assessment

Appendices

April 2016

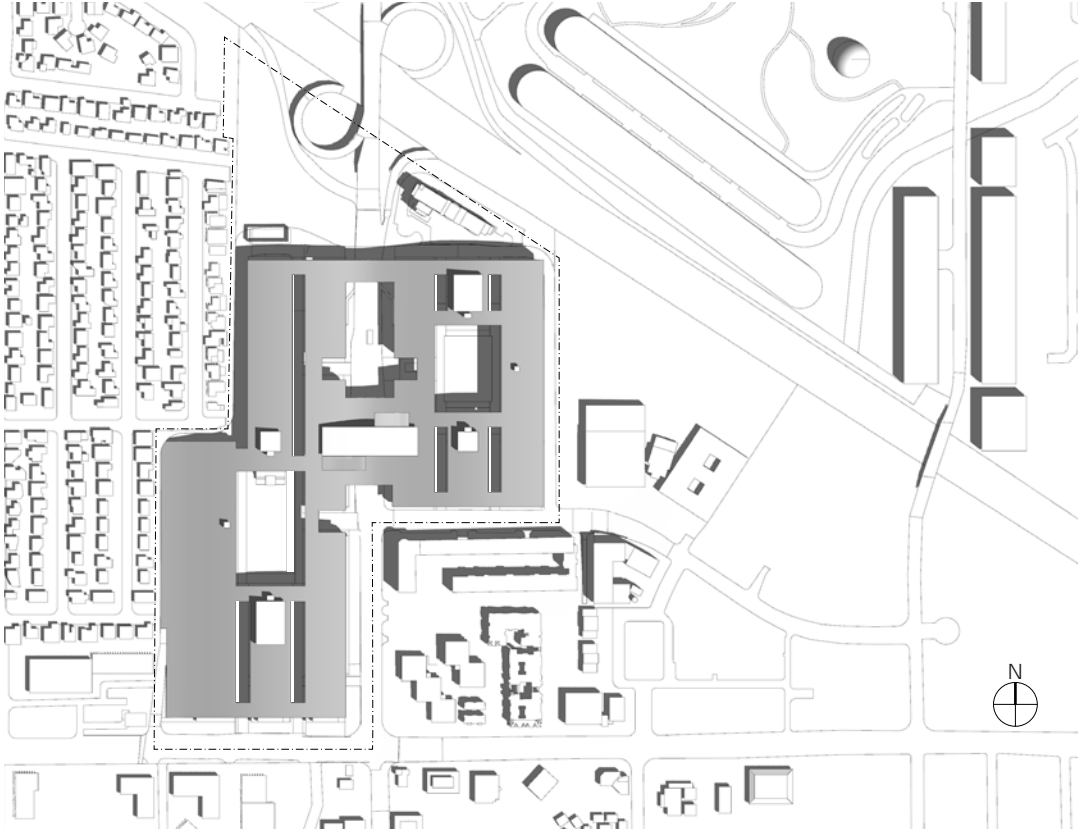
10:00 AM

March 21 - Shadow Study

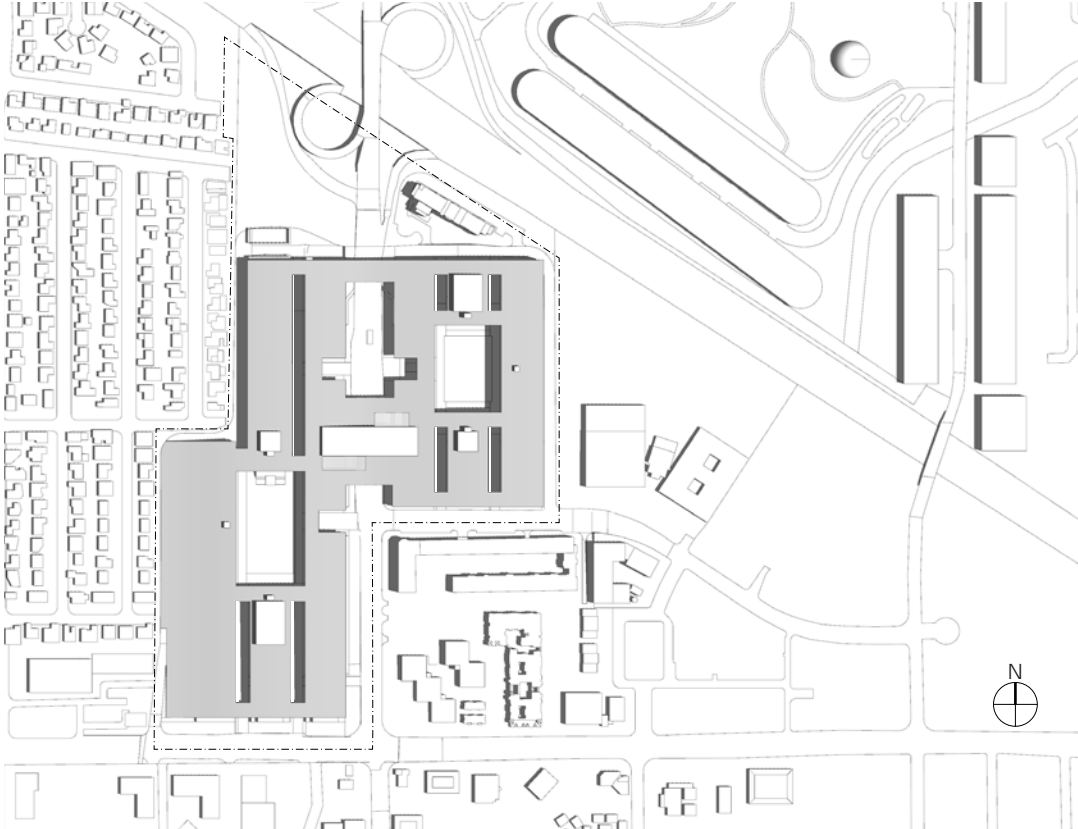
10:00 AM

June 21 - Shadow Study

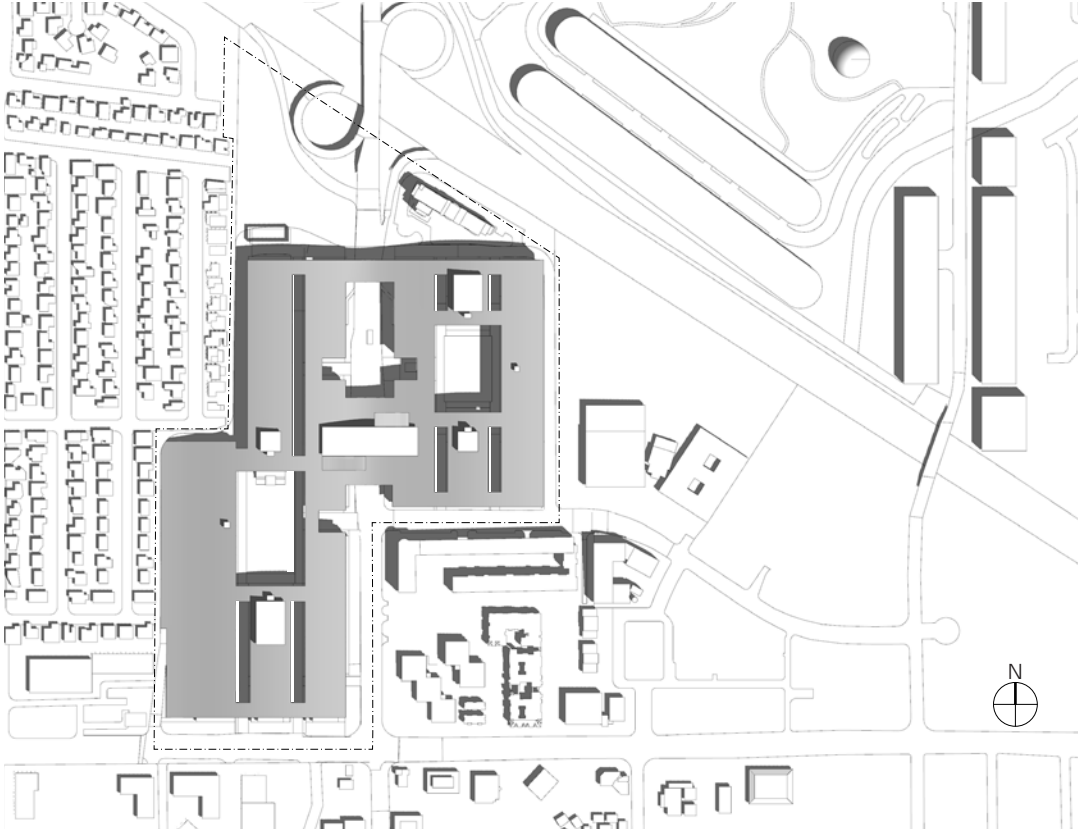
10:00 AM

September 21 - Shadow Study

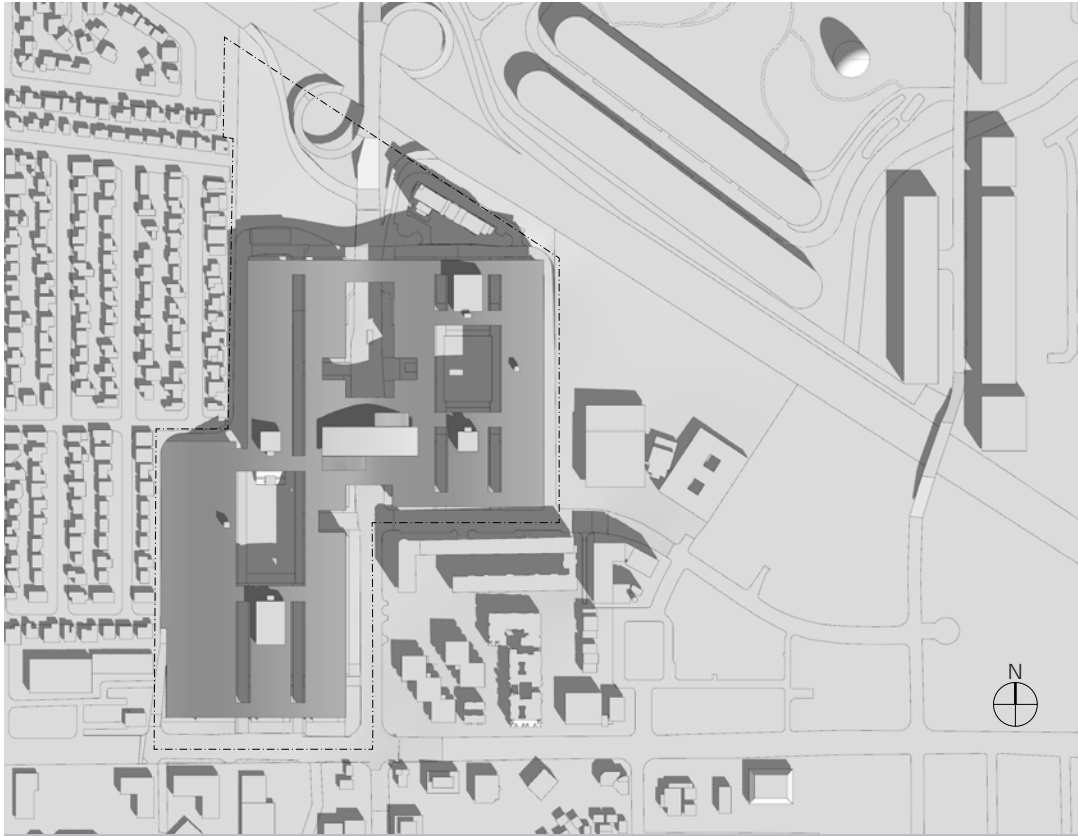
10:00 AM

December 21 - Shadow Study

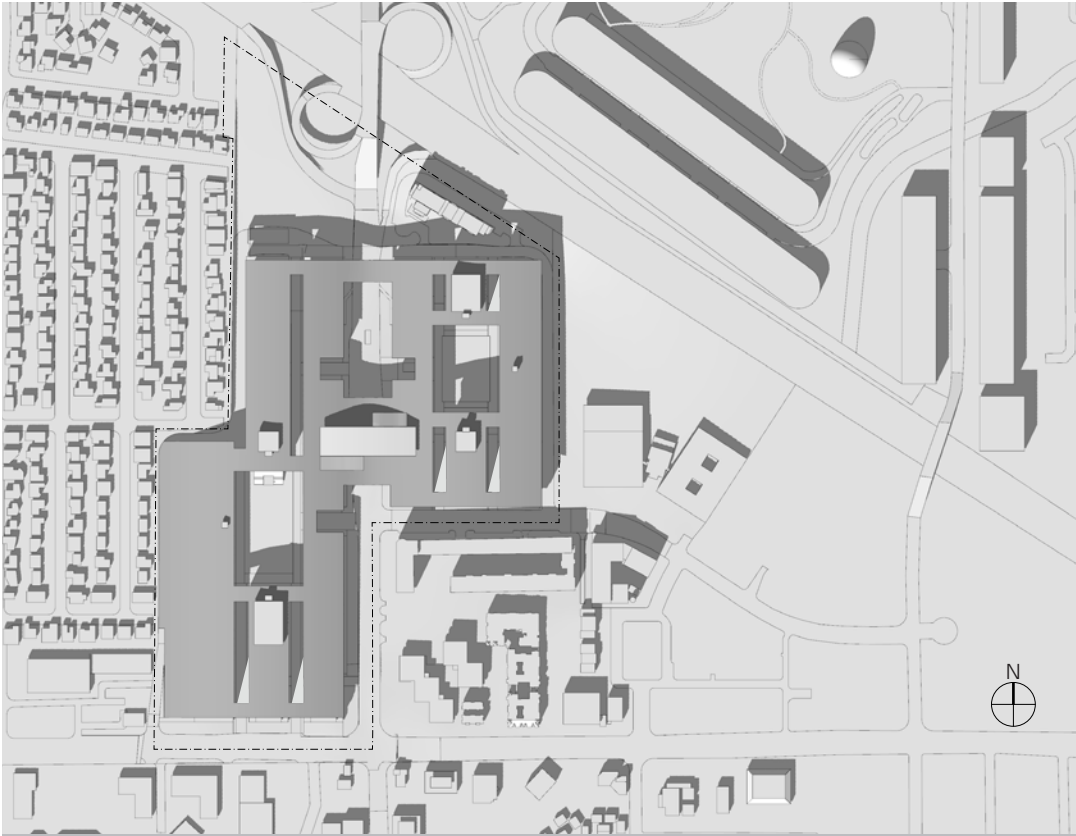
2:00 PM

December 21 - Shadow Study

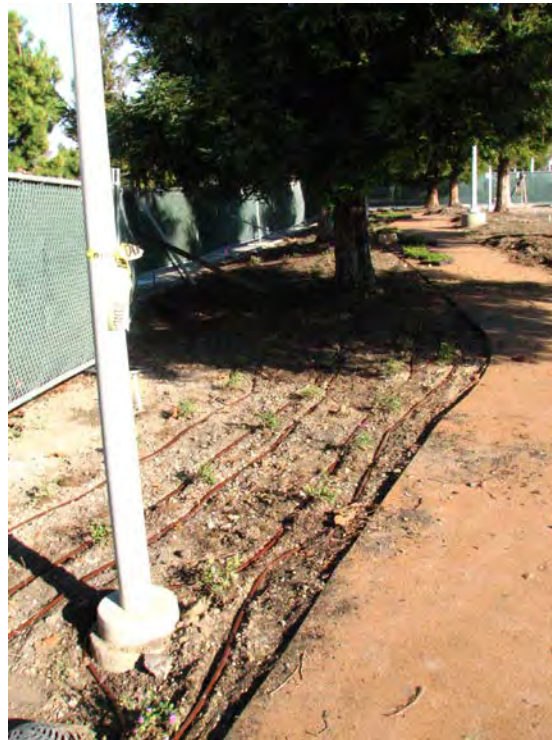
The no-dig option is optimal in terms of protecting lateral tree roots extending out from existing trees. However, vandalism is always a problem. The tubing can be buried slightly by covering it with a 4 inch thick layer of wood chip mulch to avoid some vandalism, but further measures may need to be taken to keep the tubing flush with the soil surface, such as pinning down the tubing with professional grade steel landscape U-pins, etc. See image at right.

- a. Option 1: "No Dig". This irrigation type uses flexible $\frac{1}{2}$ " diameter tubing that starts at a PVC riser at 20 feet or farther from a tree trunk of a tree being retained, and proceeds to snake over the ground to locations within 20 feet of a trunk of an existing tree where irrigation is needed. Bubblers are either affixed to the tubing itself, or to offshoot $\frac{1}{4}$ " diameter tubing with bubblers. There is also emitter line that is available in $\frac{1}{2}$ " diameter, with built in bubblers, though these tend to clog easily.

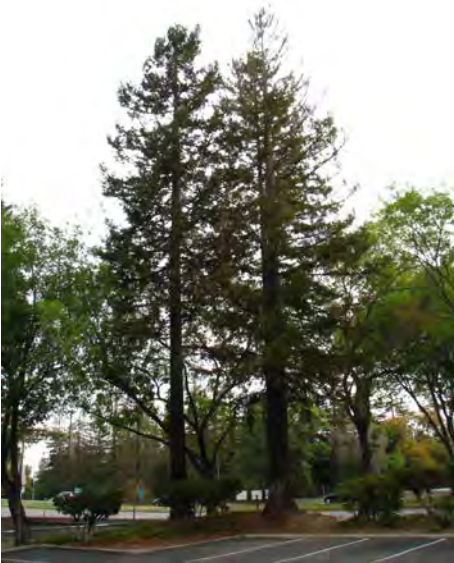
Tree #	Image	Tree #	Image
<p>285 to 289 to be removed, looking northeast</p>

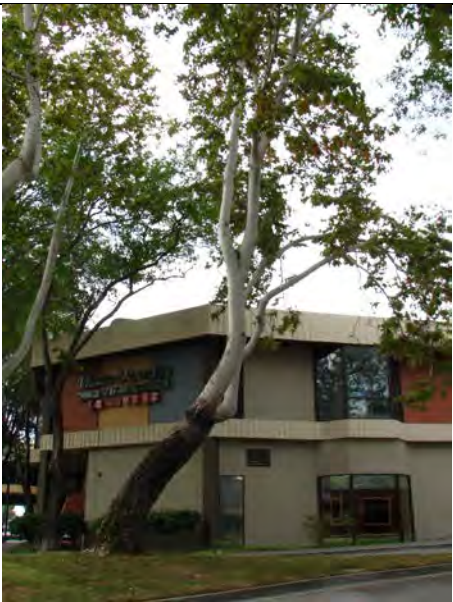
<p>Sycamore 260 initially proposed by team to be transplanted. WLCA suggests removal of tree, or redesign the plan to work around it.</p>

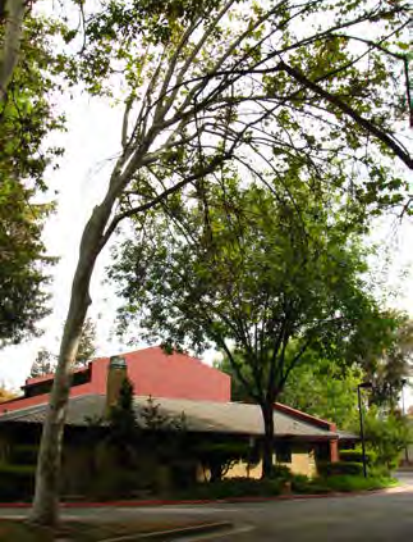
<p>416 initially proposed by the project team to be transplanted (WLCA suggests removal, or redesign the project to work around it)</p>

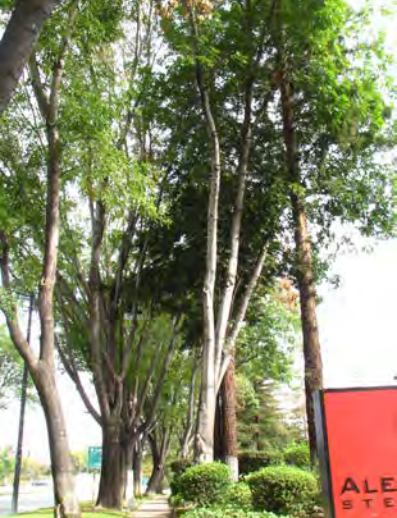
<p>426 to 444 along west side of Alexander's Steakhouse</p> <p>Some of these trees are to remain, and others are suggested by WLCA to be removed due to safety (risk) concerns</p>

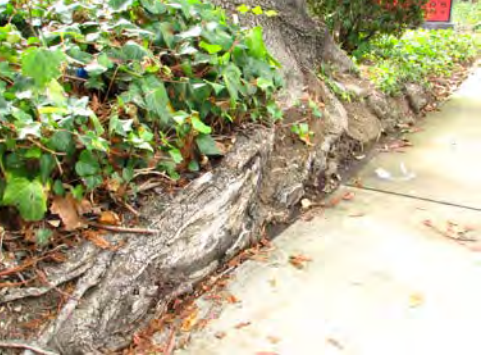
<p>Close-up of the roots severed along the west side of tree 438, (suggested by WLCA to be removed), during sidewalk replacement.</p>

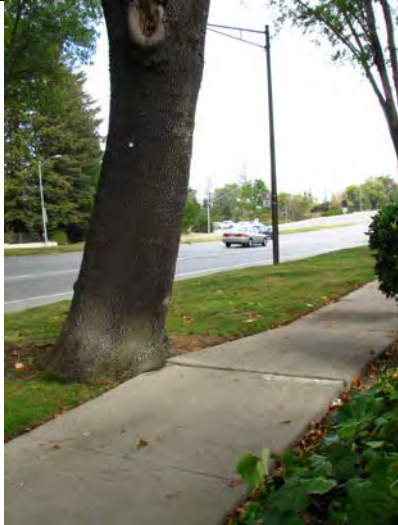
Tree #	Image	Tree #	Image
<p>Sidewalk heave (vertical displacement) along the east side of tree 431 to be retained. Infrastructure such as this with roots likely travelling under the hardscape should be left in-situ instead of being removed (if possible), since severe root loss could occur if the walk were rebuilt. Use diamond grinding to level.</p>

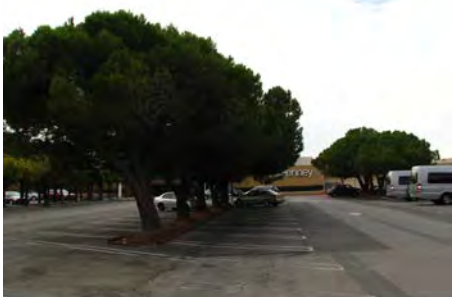
<p>Example of redwoods and ash specimens 332, 333, and 335 in very poor condition due to soil moisture deficit, at the JC Penny parking lot.</p>

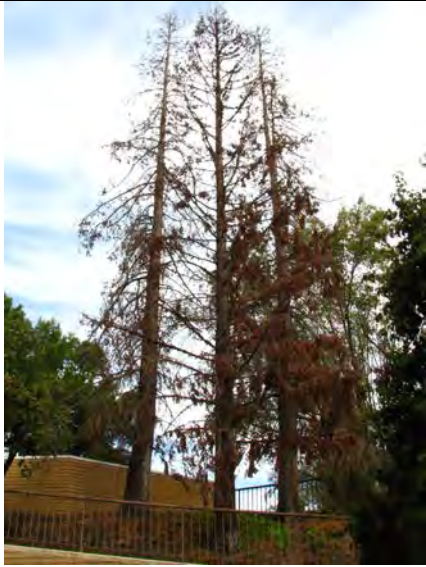
<p>Redwoods 500, 501, and 502 are dead in the southeast corner of the JC Penny parking lot area. These trees are planned to be removed.</p>

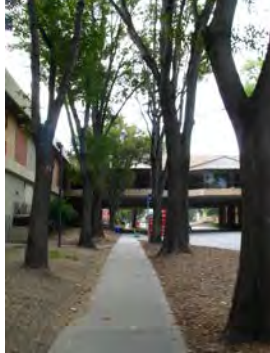
Tree #	Image	Tree #	Image
<p>Close-up of tree 267 to be removed, which exhibits a severe girdling root issue due to planting strip width which severely restricted normal lateral root extension from the trunk</p>

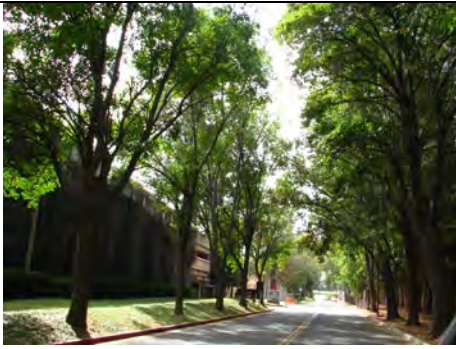
<p>Redwood specimens along the west side of west perimeter road are suffering severely from soil moisture deficit, and are generally declining or dying</p>

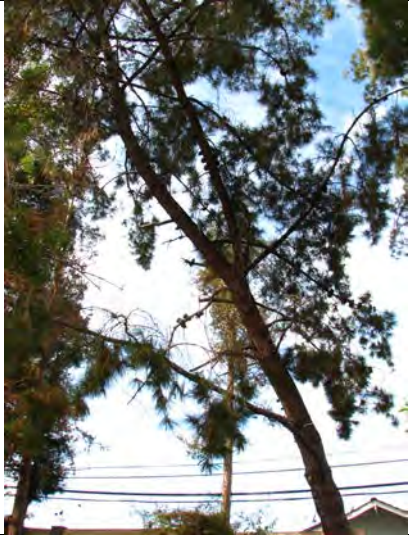
Tree #	Image	Tree #	Image
<p>Monterey pine 726 rates out with a probable risk of failure due to lean, girdling roots, etc. This tree is in WLCA's suggested removal list.</p>

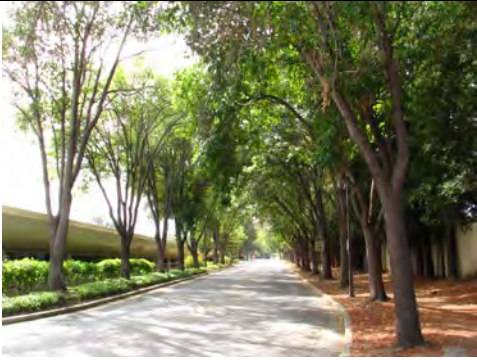
<p>The dense screen along the west side of west perimeter road as shown here near tree 771 is in danger of dying due to soil moisture deficit. Replacement of these high water use trees with drought tolerant evergreen species is a viable option.</p>

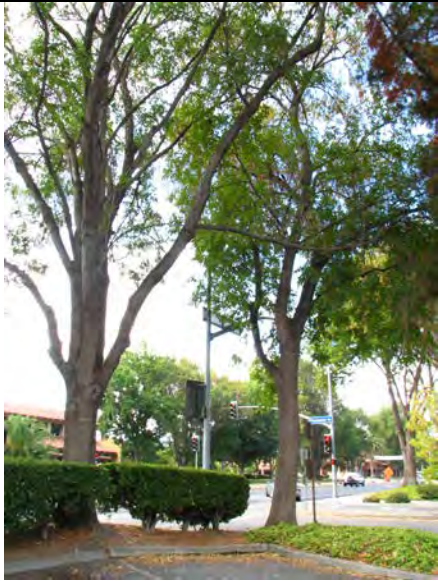
Tree #	Image	Tree #	Image
<p>Shamel ash trees 8 and 9 to be retained at the southwest corner of the project site.</p> <p>Note curb and asphalt displacement from root growth. If this hardscape is removed and replaced, severe root loss and root damage may result, ending in further tree decline or death.</p>

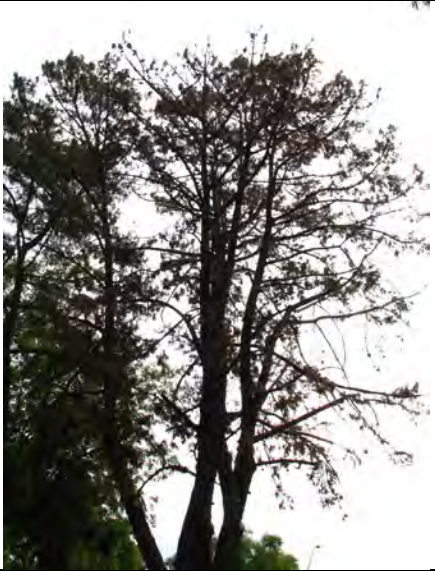
Tree #	Image	Tree #	Image
<p>Monterey pine 51 at southeast corner of the project site. This tree is dead, and needs to be removed at this time as a high risk of failure and impact to targets.</p>

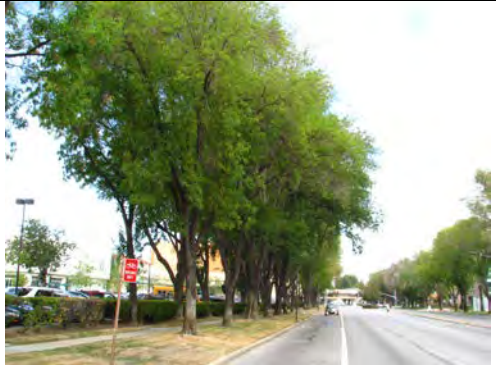
<p>Southern magnolias 1106, 1107, 1108 proposed by the project team to be retained, are in decline due to severe soil moisture deficit, and may need to be removed.</p>

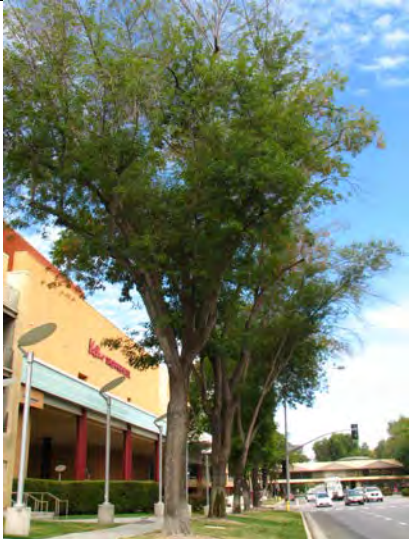
<p>Looking north at shamel ash 102, 103, 104, and 105 to be retained. Note canopy dieback in the form of live twig density decline.</p>

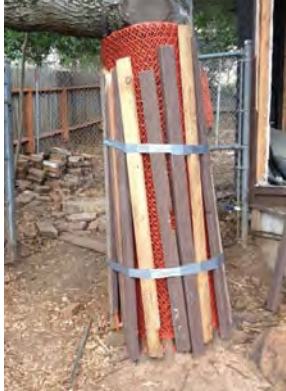
<p>219, 220, 221, 239, 240, 241, (245 through 251), 277, 278, (280 through 292), (571 through 703), (1114 through 1125).</p> <p>(<u>Not</u> including individual trees in this group that are to be removed per author recommendation in report section 1.0 line 5).</p>	1D, 1C
2	<p>TRUNK BUFFER –</p> <p>20 wraps of orange plastic with wood boards overlaid and duct taped in place around the wood</p>

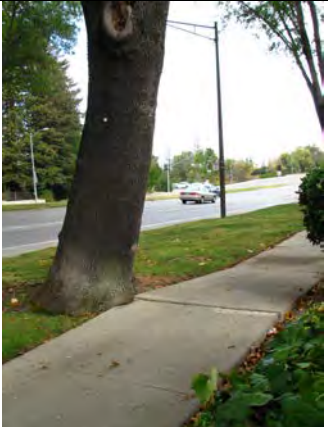
Where possible, all trees to remain	1D, 1C
5	<p>ROOT PRUNING</p> <p>Back-dig around exposed roots, and prune at right angle to root growth direction, removing all broken, shattered, or otherwise damaged sections of roots</p>		Where applicable during excavation, trenching, grading, etc.	1D, 1C
6	<p>HARDSCAPE REMAIN</p> <p>Allow existing hardscape areas to remain, where possible, to avoid root loss and root damage. Arborist monitoring required during demolition within 20 feet of trunk.</p>

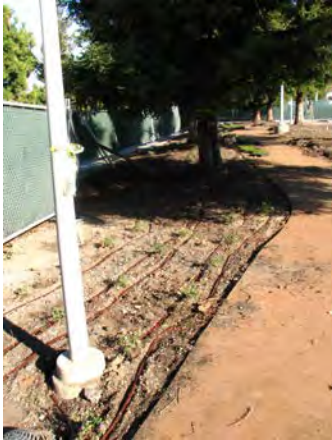
Various, along west perimeter road and N. Wolfe Rd.	1D, 1C
8	IRRIGATION PERMANENT Use no-dig over grade tubing, or max. of "6 inch cover within 20 feet of trees" as blurb-specified on all plans.

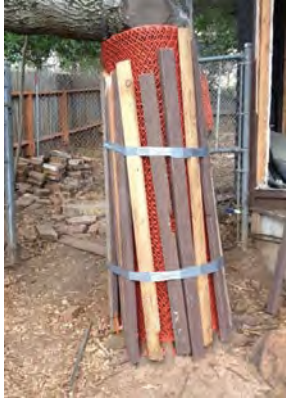
Line Number	Protection Action	Sample Image	Tree Tag Number	Phase
10	<p>TRUNK BUFFER –</p> <p>20 wraps of orange plastic with wood boards overlaid and duct taped in place around the wood</p>

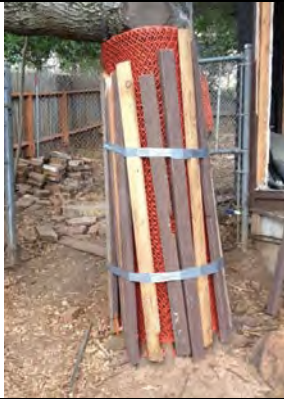
<p>102, 102, 104, 105, (459 through 475), 671, 672, 673, (704 through 839)</p> <p>(Not including individual trees in this group that are to be removed per author recommendation in report section 1.0 line 5).</p>	3D, 3C
18	<p>TRUNK BUFFER –</p> <p>20 wraps of orange plastic with wood boards overlaid and duct taped in place around the wood</p>

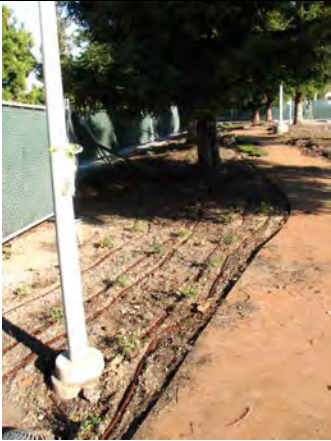
Line Number	Protection Action	Sample Image	Tree Tag Number	Phase
24	<p>IRRIGATION PERMANENT Use no-dig over grade tubing, or max. of "6 inch cover within 20 feet of trees" as blurb-specified on all plans.</p>

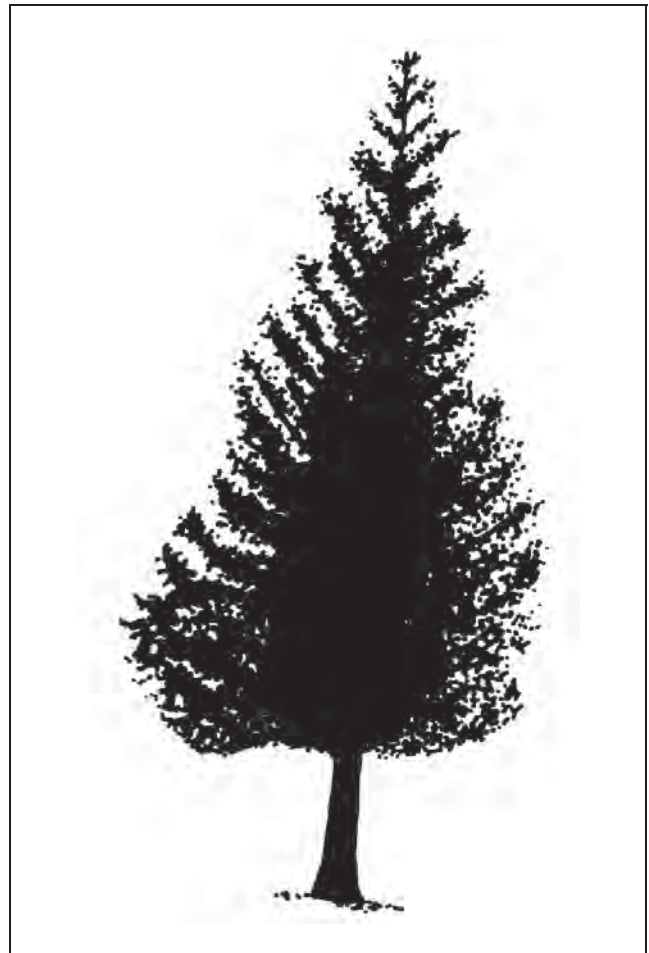
Figure 1. Mature Coast Redwood.

Sequoia sempervirens, the Coast Redwoods of California, are the tallest trees in the world (Fig. 1). They can vary greatly when grown from seed, but varieties are available now which have been vegetatively propagated and they retain true characteristics. Redwoods grow three to five feet per year and are remarkably pest-free. They live to be many hundreds of years old; some live to several thousand years. Bark is particularly beautiful, turning a bright orange on older trees. It may grow poorly in zones 9 and 10 in Florida.

Height: 60 to 120 feet
Spread: 25 to 35 feet
Crown uniformity: symmetrical canopy with a regular (or smooth) outline, and individuals have more or less identical crown forms
Crown shape: pyramidal
Crown density: moderate

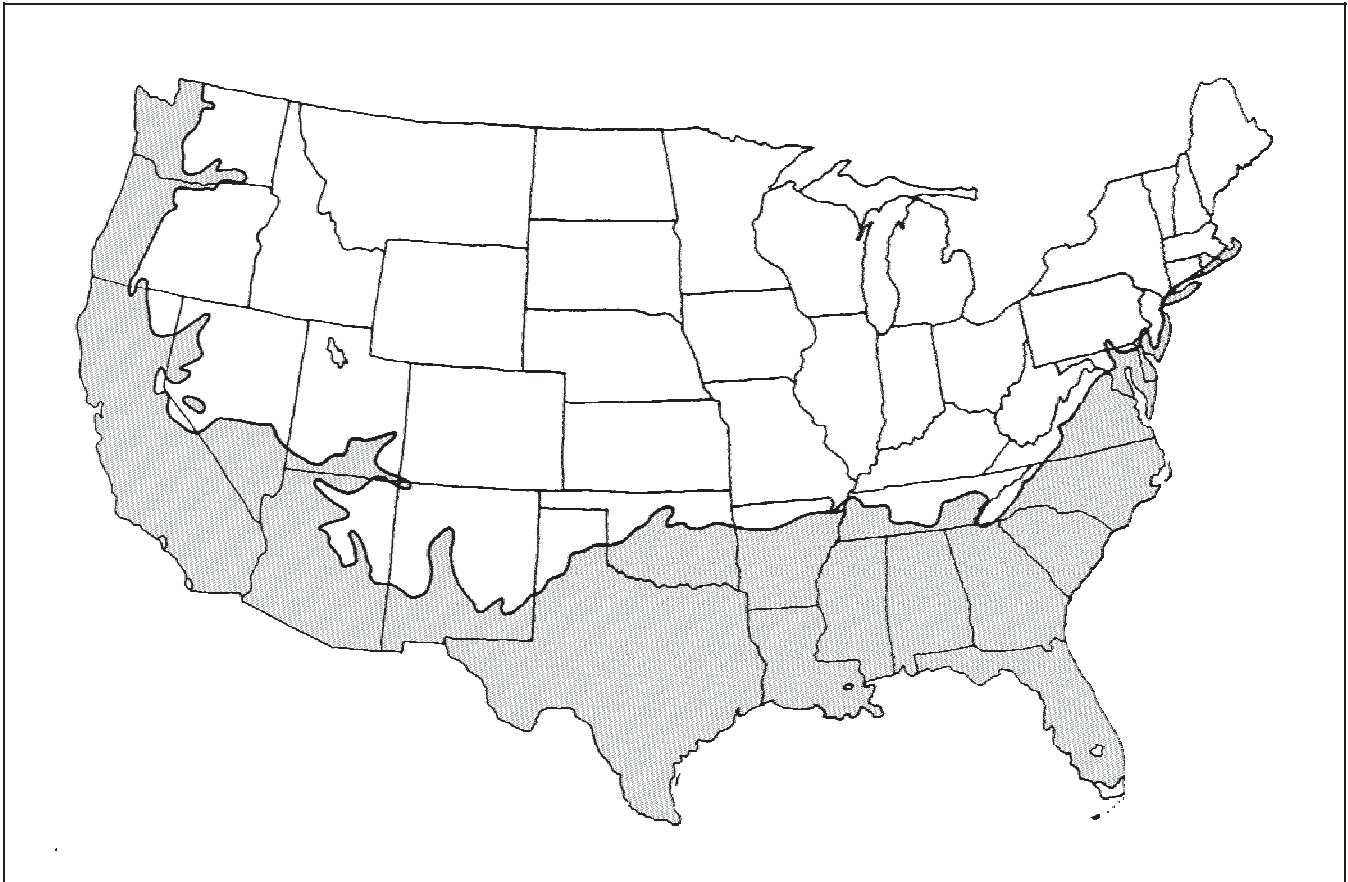
Figure 2. Shaded area represents potential planting range.
