Assessment of 895 Trees  
at  
The Hills at Vallco Project  
North Wolfe Road  
Cupertino, California

Prepared for:  
Vallco Property Owner LLC  
c/o Mr. Reed Moulds  
Sand Hill Property Co.  
2882 Sand Hill Road, Suite 241  
Menlo Park, CA 94025

10/5/2015, Revised 10/30/2015

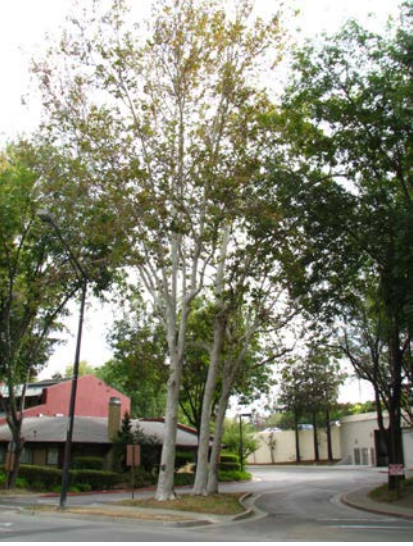
Tree #	Image	Tree #	Image
<p>414 and 415 to be retained</p>

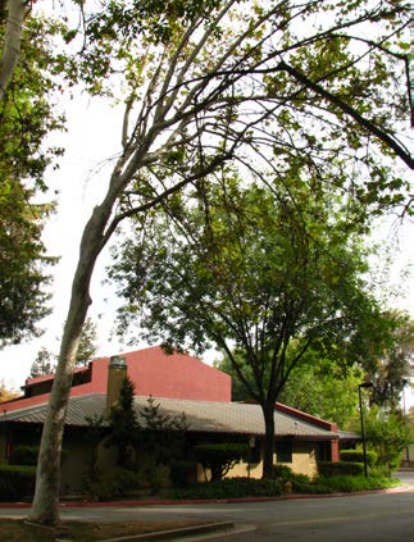
2. **Sycamore #416.** This tree is in fair overall condition (50% out of 100% possible points), which is the lowest possible "fair" rating just 1 point above the threshold for "poor" (49%).

<p>416 initially proposed by the project team to be transplanted (WLCA suggests removal, or redesign the project to work around it)</p>

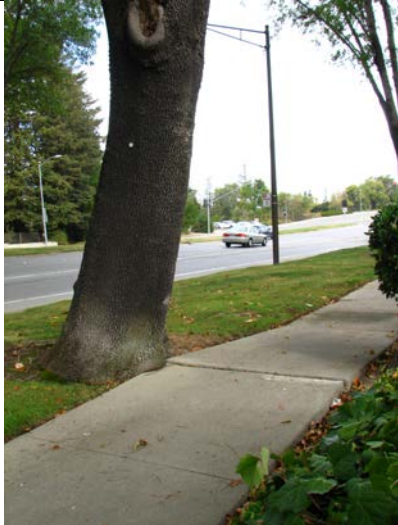
Tree #	Image	Tree #	Image
<p>Sidewalk heave (vertical displacement) along the east side of tree 431 to be retained. Infrastructure such as this with roots likely travelling under the hardscape should be left in-situ instead of being removed (if possible), since severe root loss could occur if the walk were rebuilt. Use diamond grinding to level.</p>

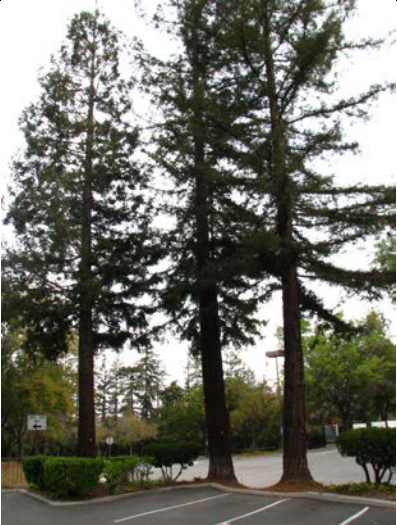
<p>Redwoods 423, 424, 425 to be removed at the steakhouse parking lot.</p>

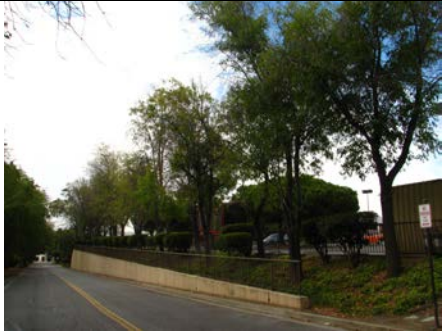
Tree #	Image	Tree #	Image
<p>Trees 338 to 358 to be removed along the east side of the JC Penny parking lot.</p>

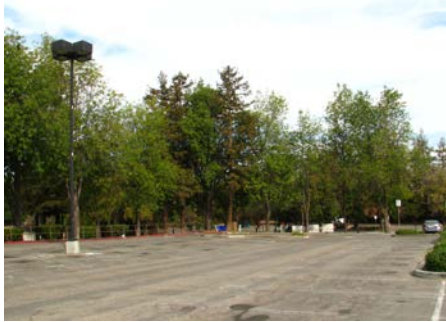
<p>Shamel ash and redwoods 396 to 404 to be removed at the west side of JC Penny parking lot</p>

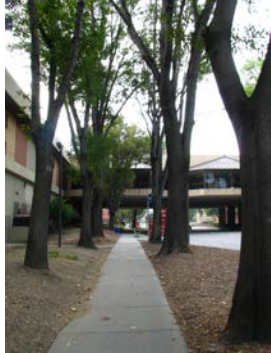
<p>Shamel ash 452 to 457 to be removed from the east side of N. Wolfe Rd.</p>

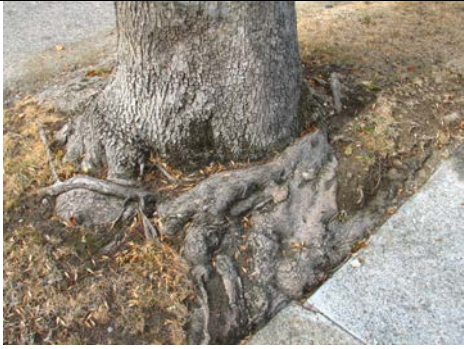
Tree #	Image	Tree #	Image
<p>Close-up of tree 267 to be removed, which exhibits a severe girdling root issue due to planting strip width which severely restricted normal lateral root extension from the trunk</p>

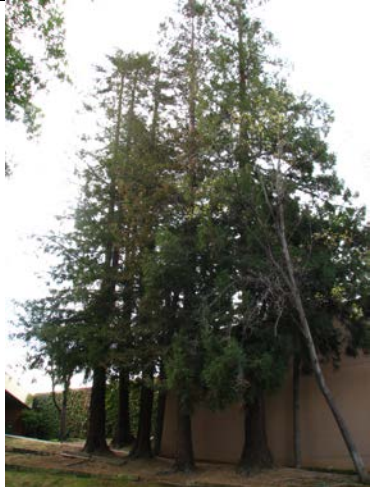
<p>Grove of redwoods 204 to 218 to be removed just west of Dynasty Restaurant.</p>

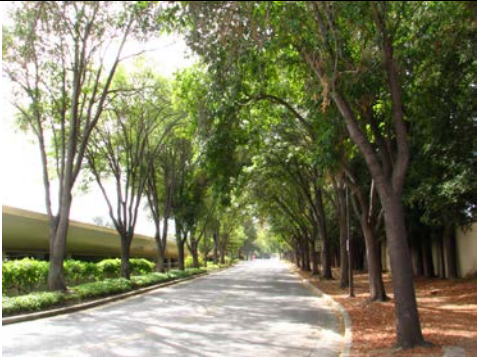
<p>Looking south along west perimeter road, again with trees on left to be removed (tree 165 southward), and trees on right to be retained (tree 771 southward)</p>

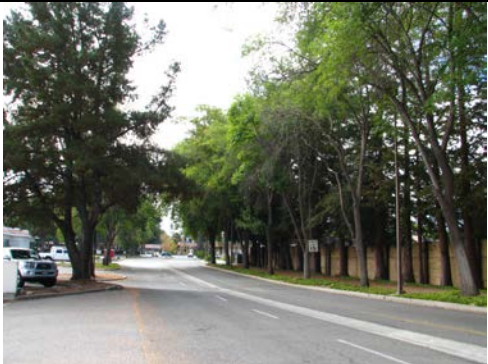
<p>The dense screen along the west side of west perimeter road as shown here near tree 771 is in danger of dying due to soil moisture deficit. Replacement of these high water use trees with drought tolerant evergreen species is a viable option.</p>

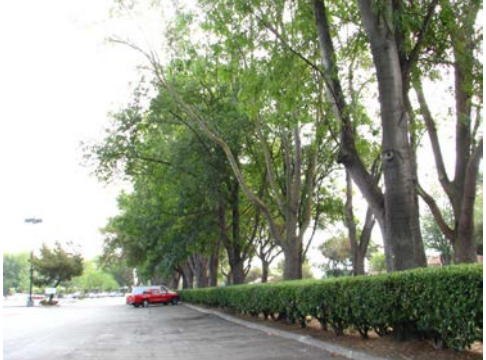
Tree #	Image	Tree #	Image
<p>Shamel ash trees 8 and 9 to be retained at the southwest corner of the Vallco site.</p> <p>Note curb and asphalt displacement from root growth. If this hardscape is removed and replaced, severe root loss and root damage may result, ending in further tree decline or death.</p>

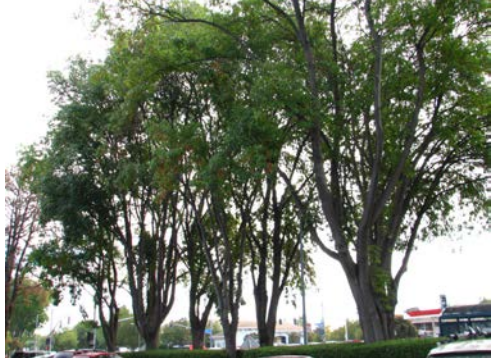
<p>Shamel ash 42 to 50 to be retained along south border.</p> <p>Looking southeast.</p>

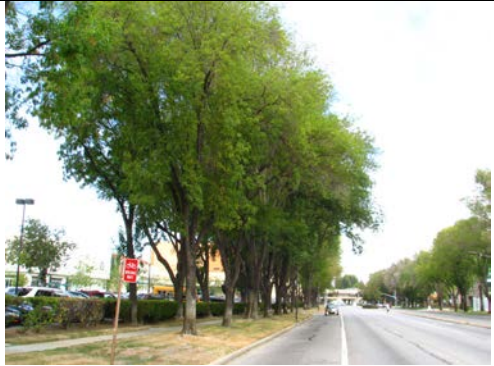
<p>Looking north at shamel ash 55, 57, 59, 61, 63, 65 to be retained.</p>

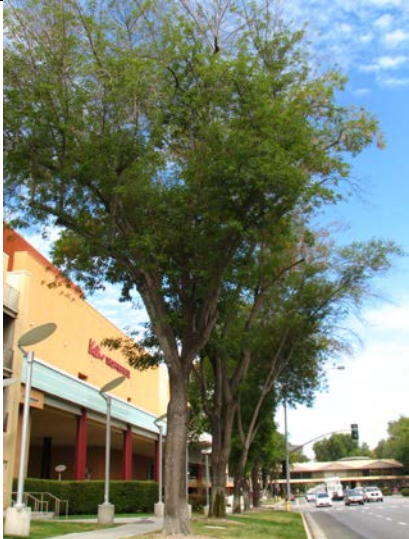
<p>Looking north at shamel ash 102, 103, 104, and 105 to be retained. Note canopy dieback in the form of live twig density decline.</p>

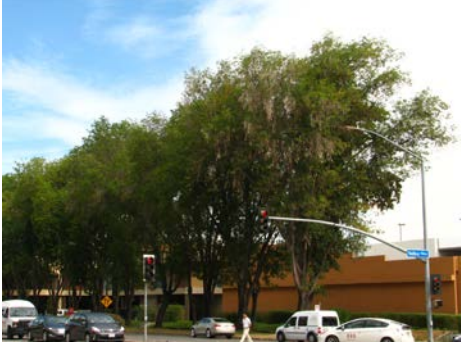
Tree #	Image	Tree #	Image
<p>Looking northeast at shamel ash 459 to 475 to be retained along the east side of N. Wolfe Rd.</p>

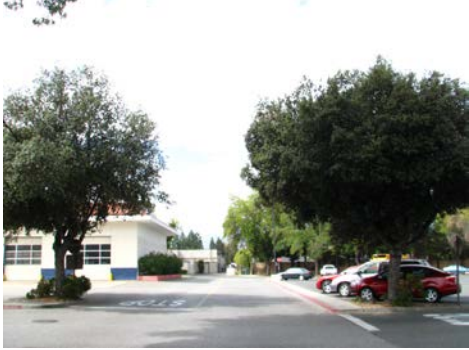
<p>Long-lived, drought tolerant oak species like these two existing holly oaks 97 and 98 to be removed at Vallco are the types of trees we should be installing on the proposed Hills at Vallco project.</p>
