# Cupertino City Hall Alternates Study Structural Evaluation:

10300 Torre Avenue, Cupertino, CA 95014-3202

Tipping Mar  
1906 Shattuck Avenue  
Berkeley, CA 94704  
510.549.1906 tel | 510.549.1912 fax  
TM Job No. 2014,094.00

**September 29, 2014**

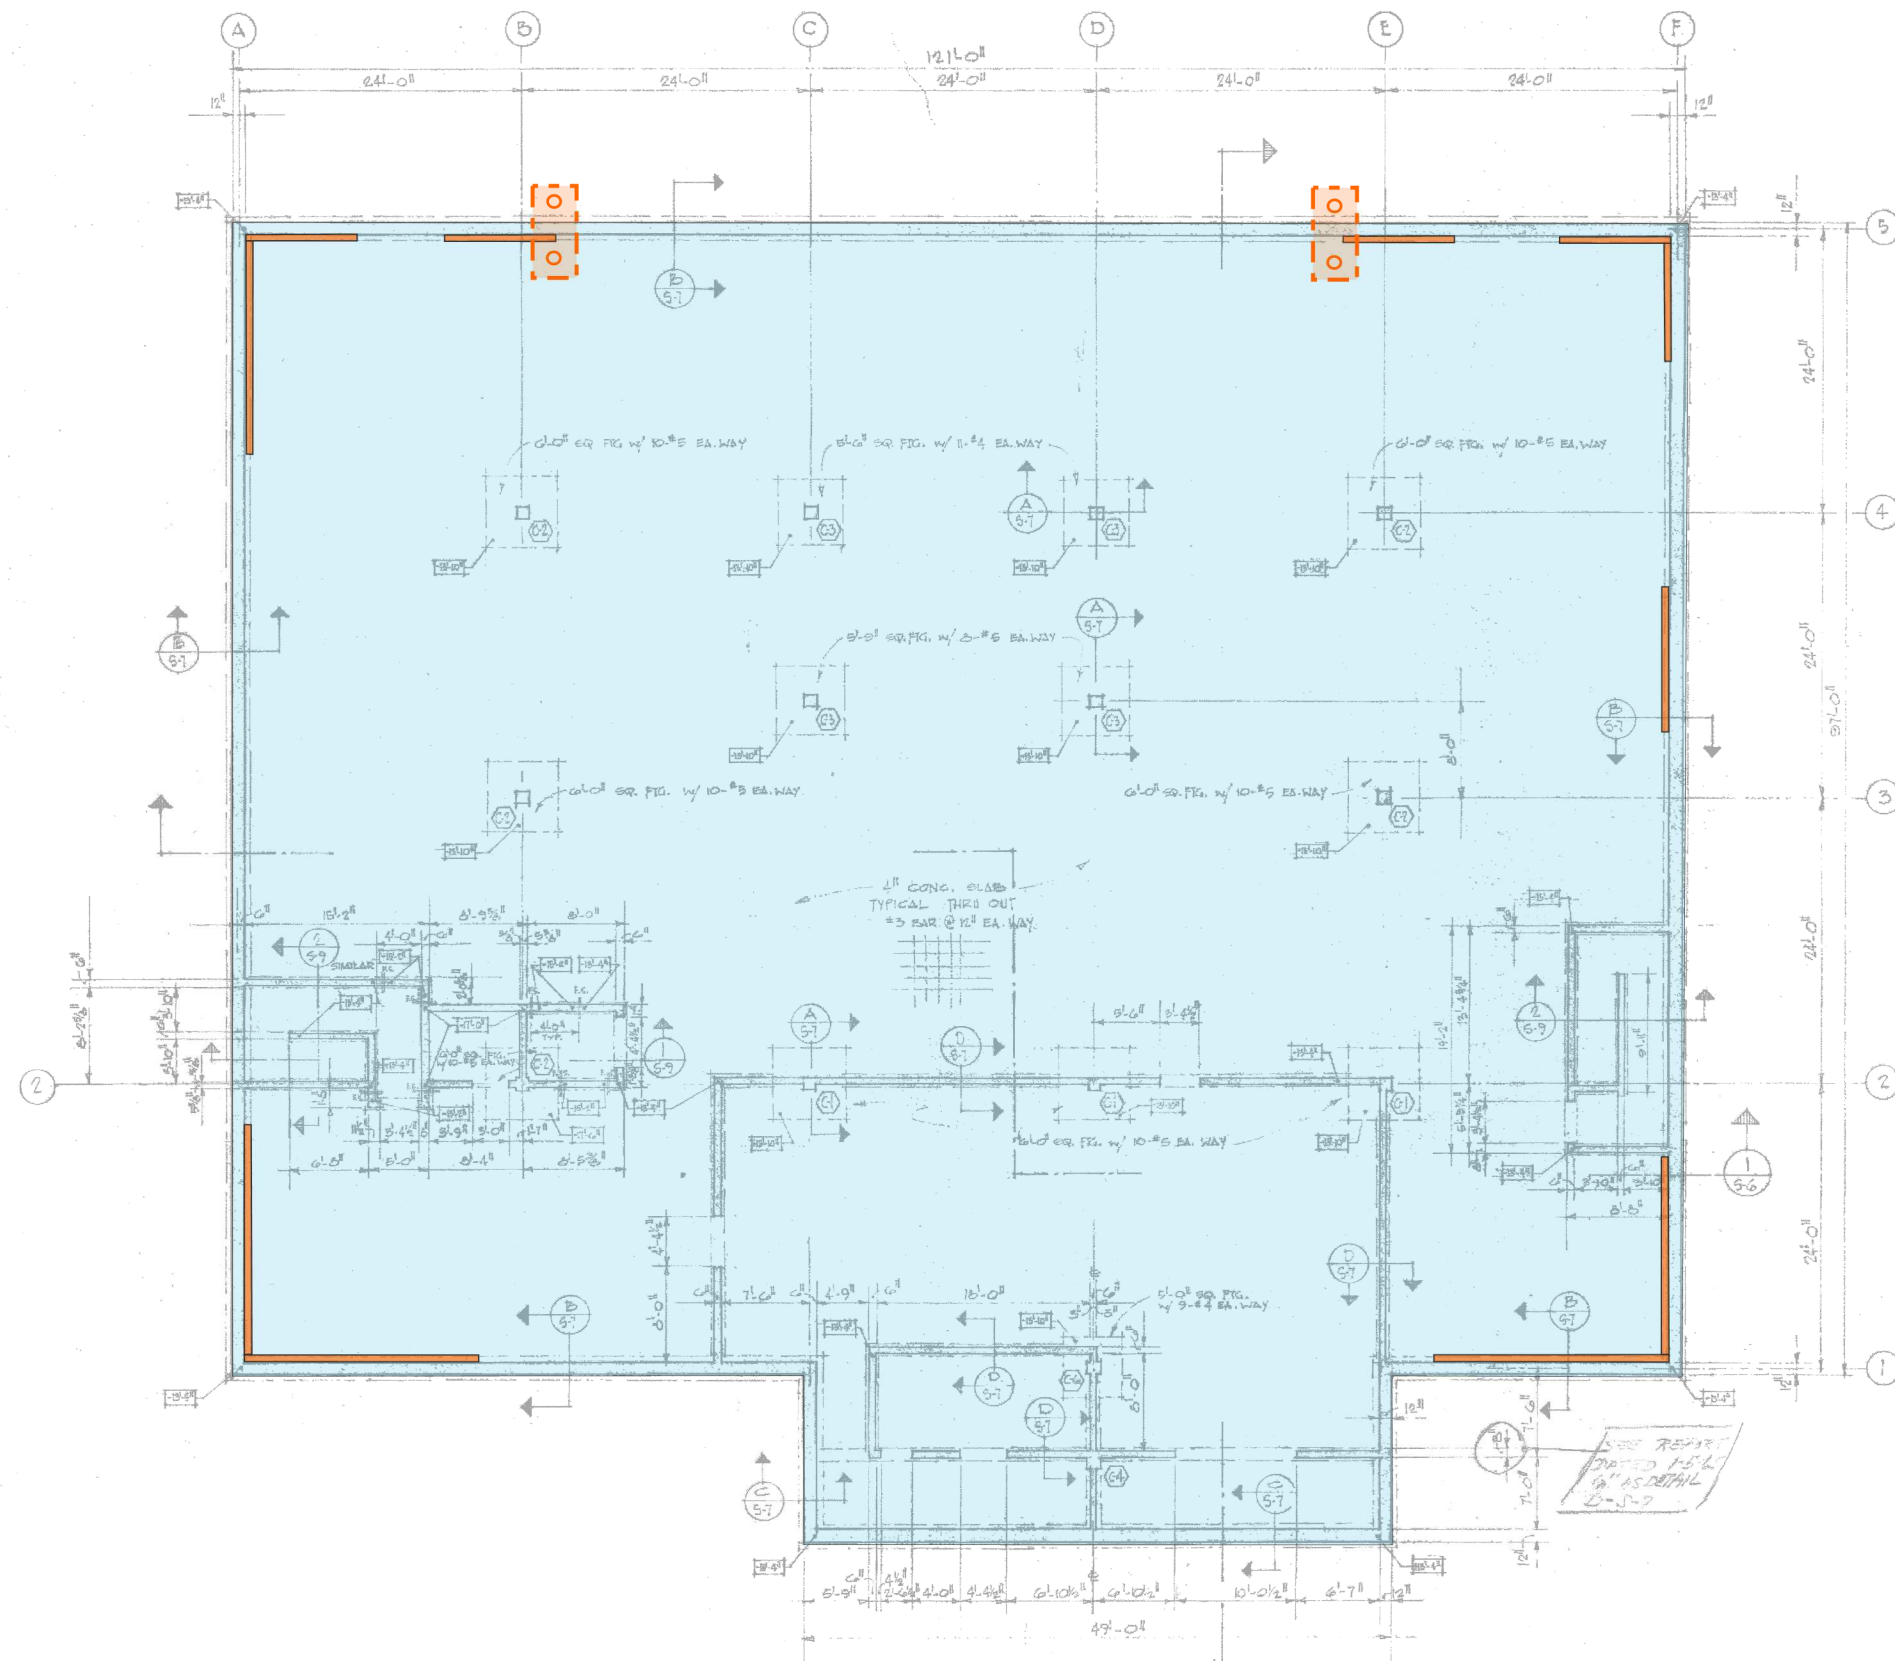
Additional shear walls extending from foundations to roof should be added to provide new/strengthened vertical seismic force resisting elements for the existing structure. The new shear walls will typically be 12" thick concrete walls from the top of existing basement walls to the underside of the roof and 6" thick concrete walls that are overlapped and connected to the face of the existing basement walls with reinforcement dowels, as shown in Detail 3 of Sheet S3. Where the wall length is limited at the north elevation within the basement level, two new new pile caps, with two micro-piles at each cap, should be provided to increase the shear wall overturning resistance along this line and protect the existing very lightly reinforced foundation from associate seismic damage.

- (N) Concrete Wall
- (N) Pile Cap with Micropiles  
 Provide 4' wide x 6' long x 4' deep pile cap with 2 micropiles at each cap. Micropile capacity +/- 150 kip design load.

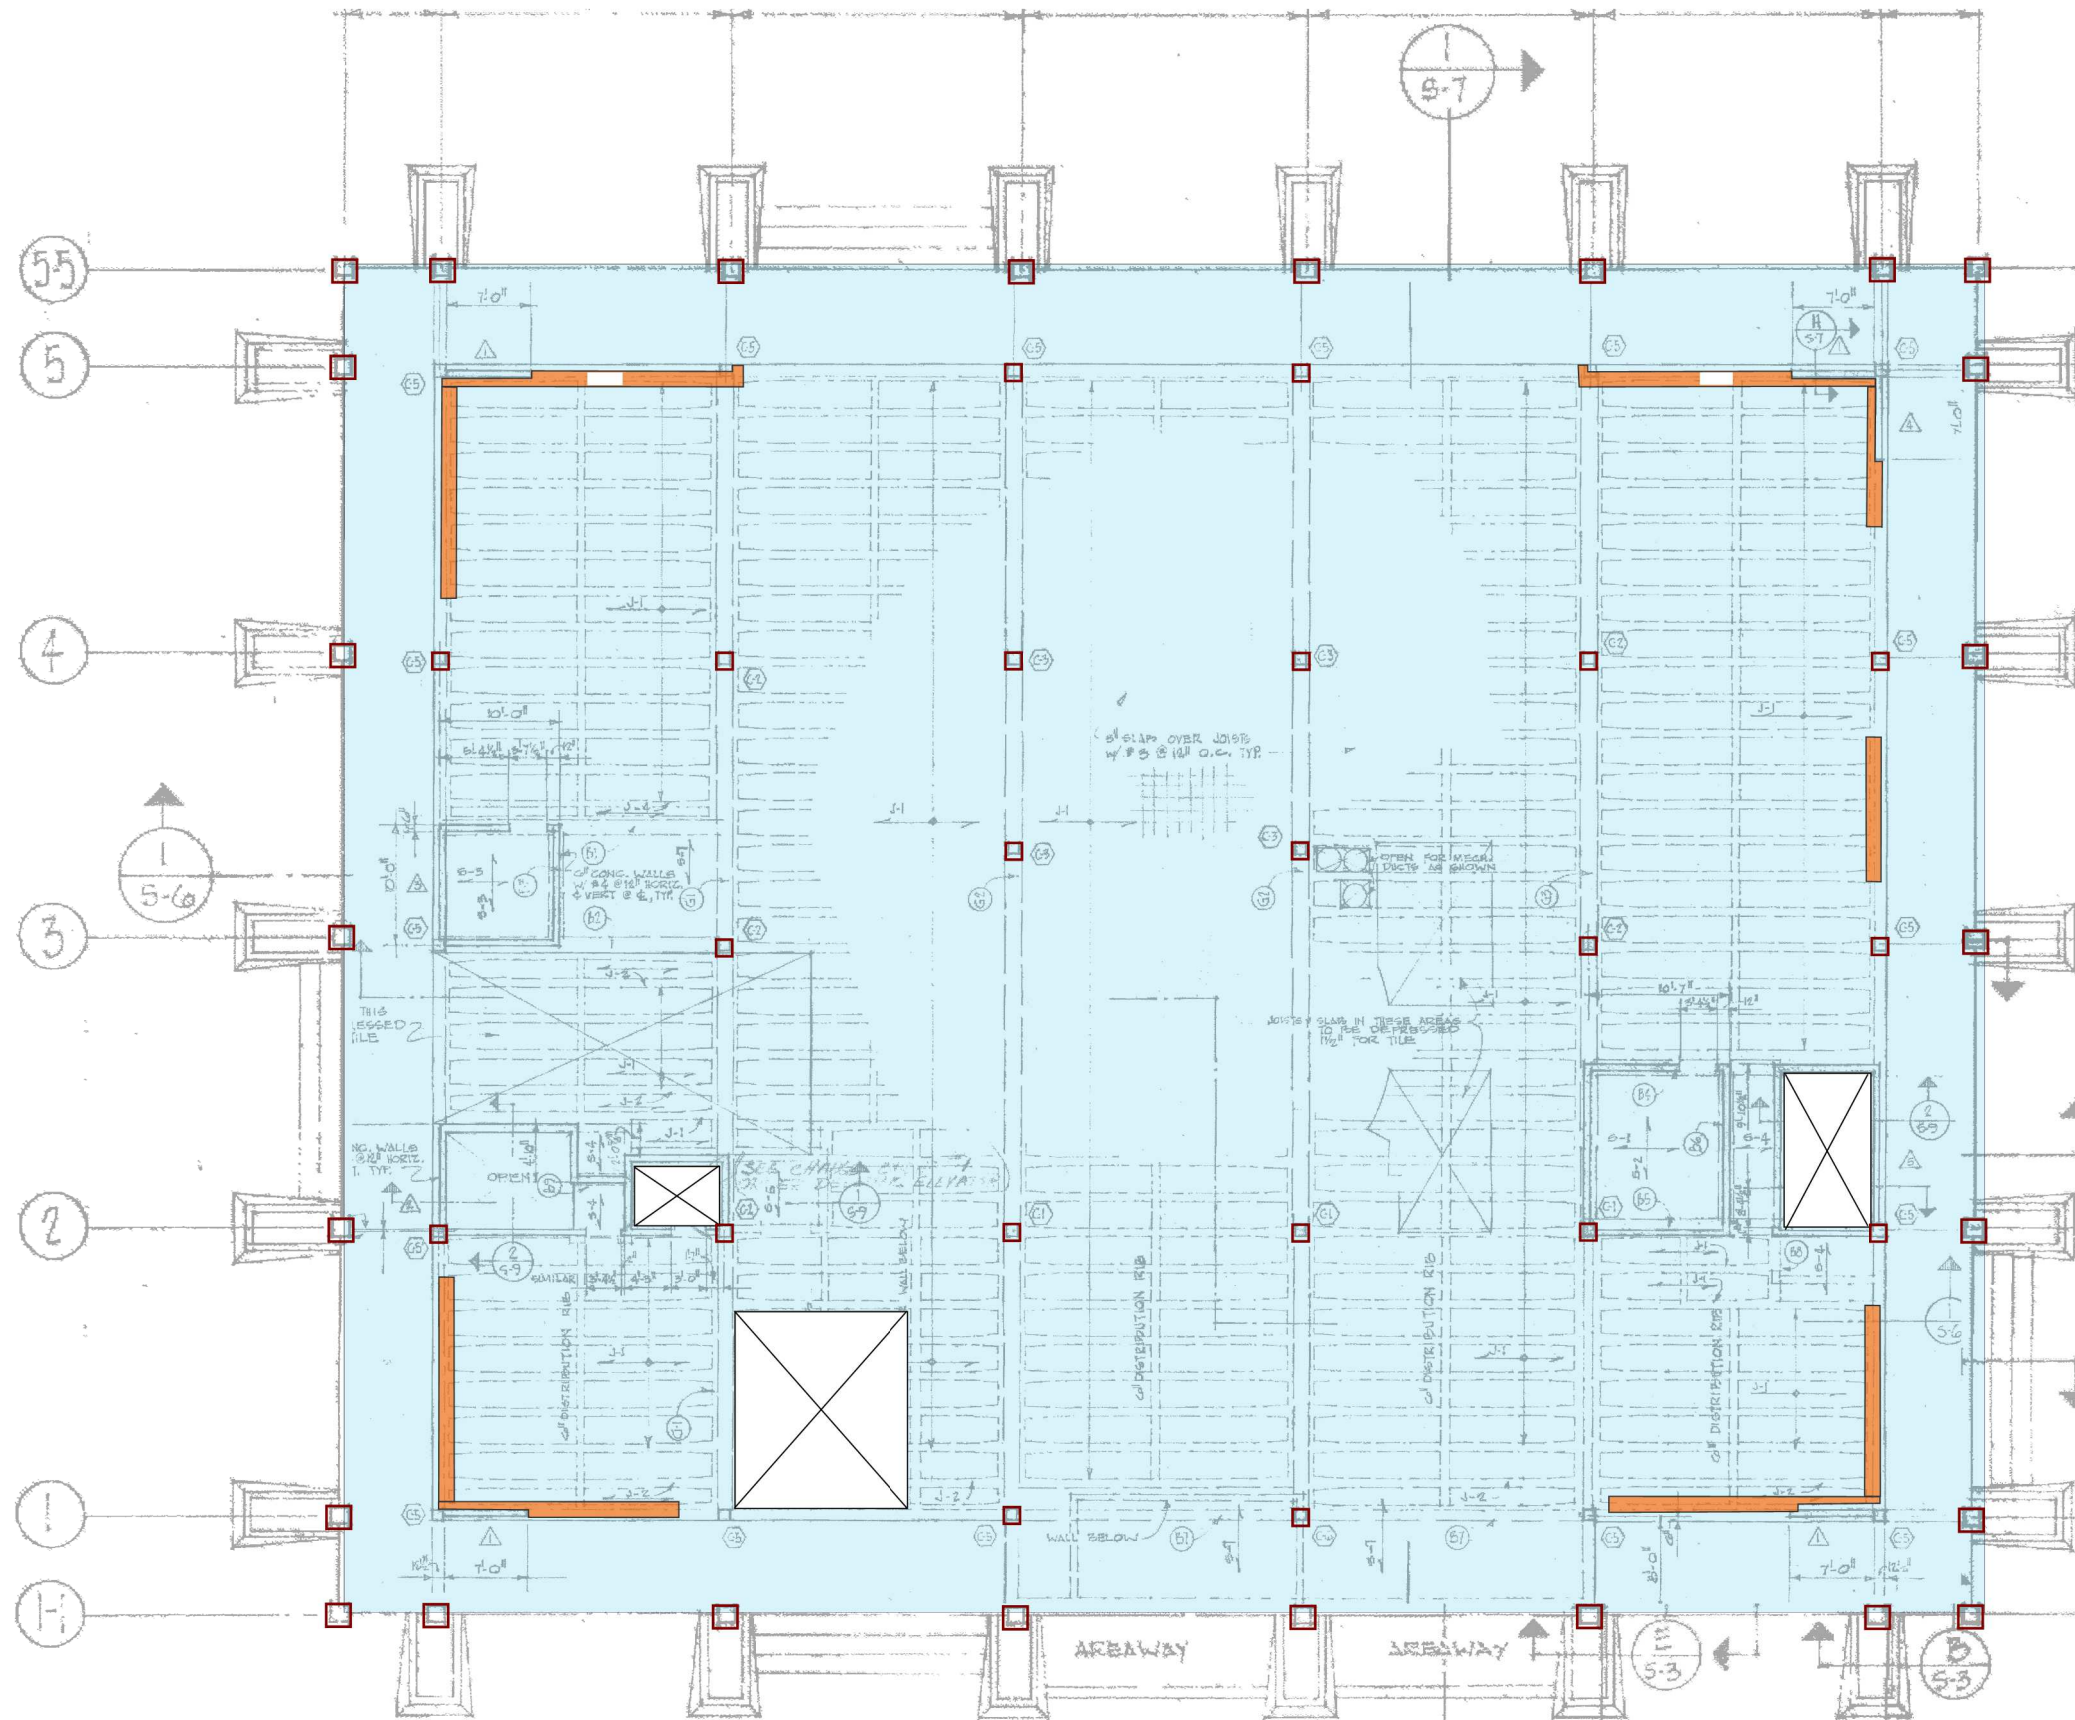
The concrete columns are connected to all floor levels and to the roof. As such, they will deform as they drift with the rest of the building during an earthquake. Bending moments and shear forces will be induced in these columns as they sway with the building during a seismic event. The long span and inherent flexibility of the wood roof diaphragm will also contribute to the anticipated seismic roof drift making these under-reinforced columns very susceptible to seismic damage. The existing concrete columns have limited confinement reinforcement ties around the longitudinal reinforcements, as noted earlier in this report. Sufficient lateral ties are required in modern building codes to properly confine the longitudinal bars and the concrete core in order for the columns to continue carrying gravity loads when the columns are displaced. The lack of confinement ties is likely to result in limited displacement ductility for the concrete column. The existing columns are to be wrapped and strengthened with fiber reinforced polymer. Wrapping the existing columns will increase the displacement ductility for gravity load carrying capacity.

- (N) Concrete Wall
- (N) FRP Wrap @ (E) Columns
