APPENDIX E:
GEOTECHNICAL DATA

TYPE OF SERVICES	Geotechnical and Geologic Hazard Investigation
PROJECT NAME	The Forum Senior Community Update
LOCATION	23500 Cristo Rey Drive Cupertino, California
CLIENT	The Forum at Rancho San Antonio
PROJECT NUMBER	905-1-1
DATE	April 14, 2017

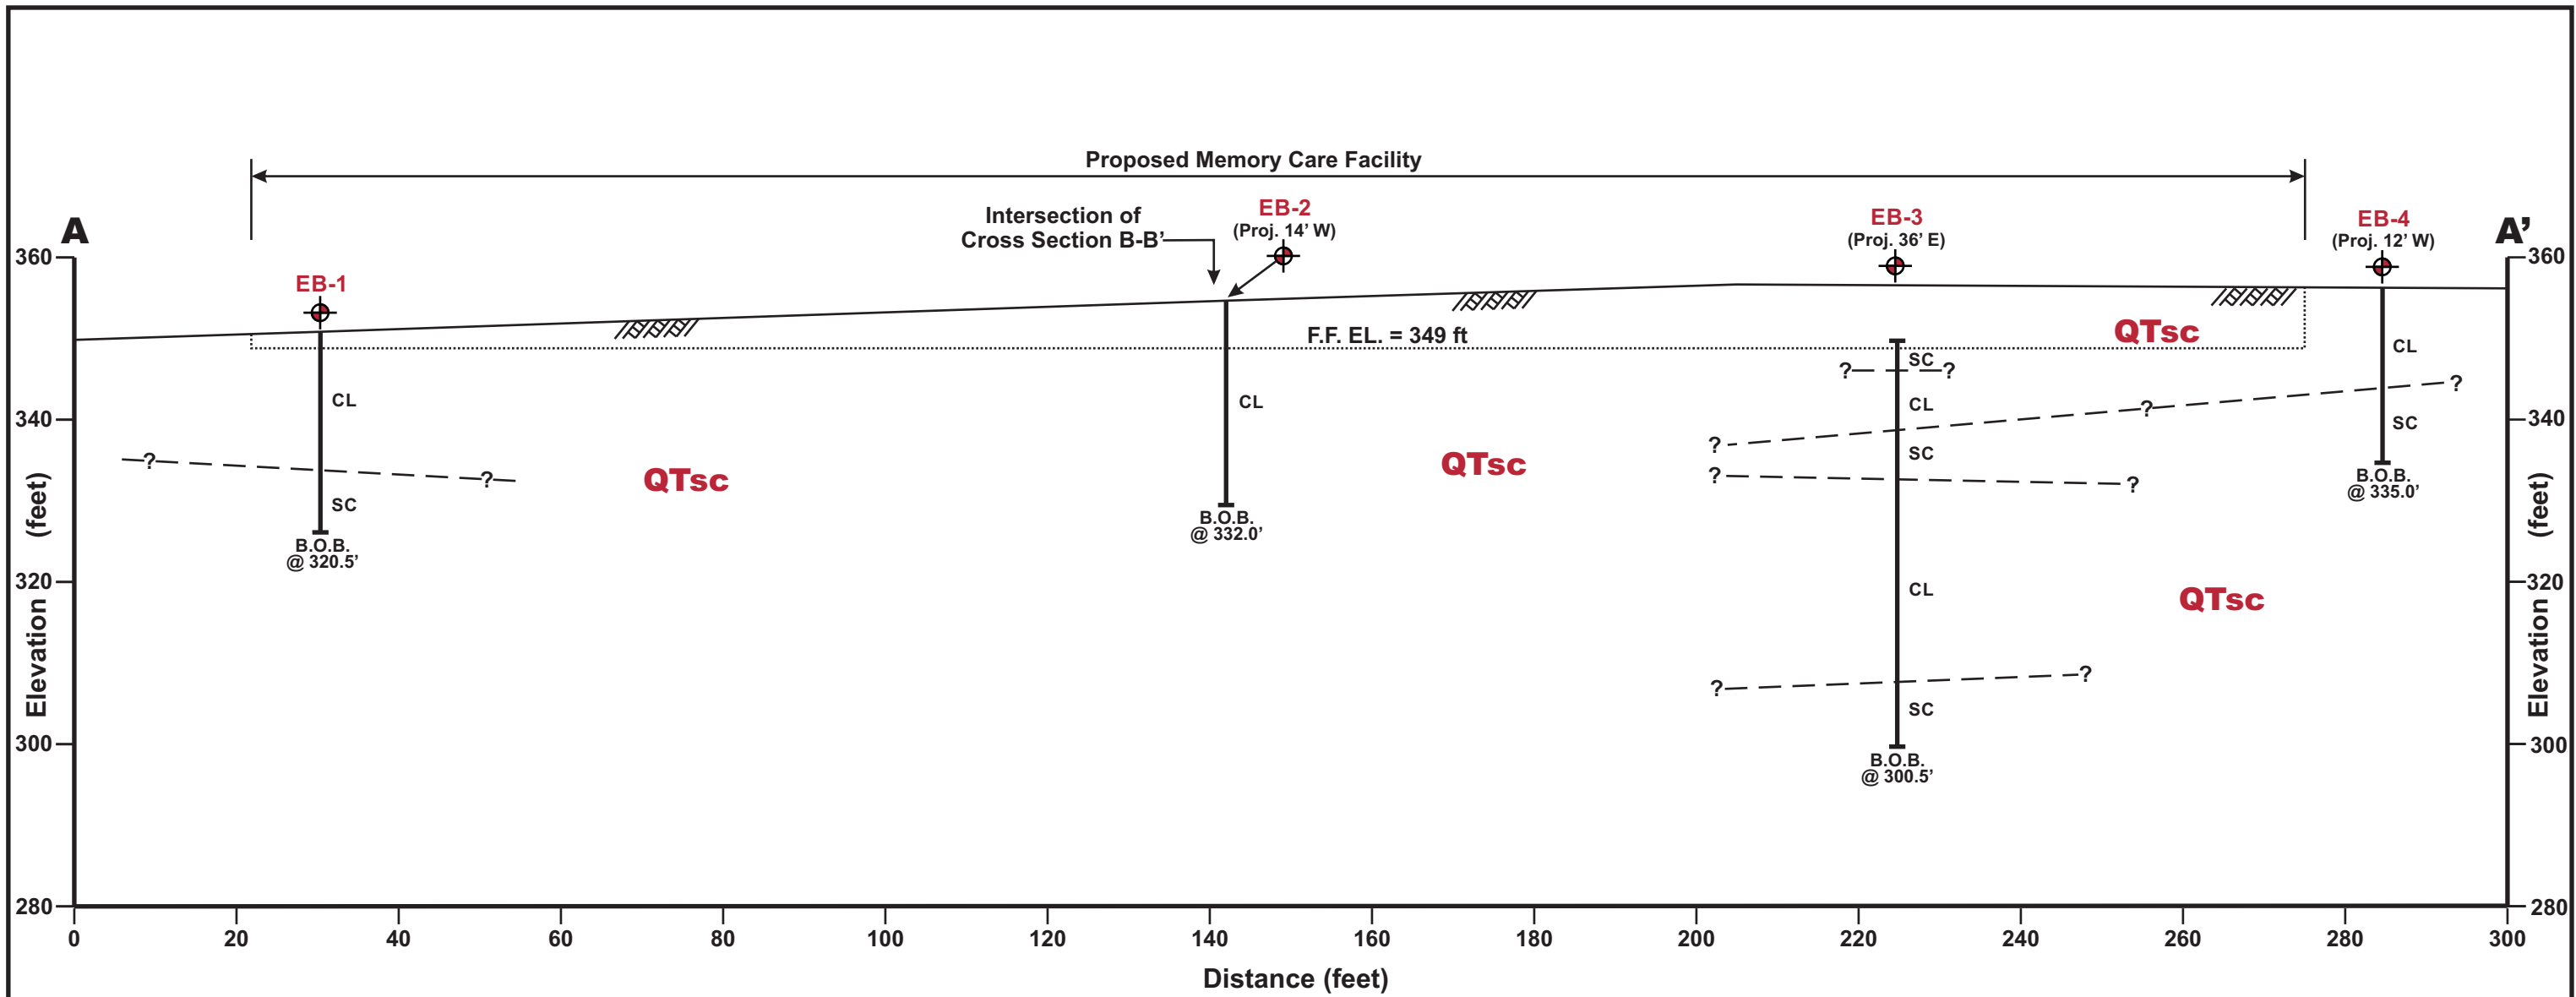
CORNERSTONE EARTH GROUP	Geologic Cross Section A-A' - Memory Care Facility		Project Number 905-1-1
	The Forum at Rancho San Antonio Cupertino, CA		Figure Number Figure 7A
	Date March 2017	Drawn By RRN

Section A-A'
(View Looking East)
1"=20' H:V

The approximate distribution and thickness of various geologic units are depicted on The Site Plan & Geologic Maps for the specific development areas, as shown on Figures 6A through 6E. Geologic cross sections at the proposed Memory Care facility are presented on Figures 7A and 7B. A geologic cross at the proposed Skilled Nursing Facility is presented on Figure 7C. Descriptions of the geologic units on or adjacent to the subject property are provided below based on our subsurface exploration and review of previous site investigations (listed in order of youngest to oldest age):

Based on conditions encountered in Borings EB-1 through EB-4, the soils in the top 2½ to 6 feet above Santa Clara Formation bedrock generally consisted of hard lean clays with sand, sandy lean clays, and medium dense clayey sands. In Boring EB-4, fill material consisting of hard sandy lean clay and lean clay with sand was encountered until about 2½ feet. The Santa Clara Formation consisted mostly of hard lean clays with sand and sandy lean clays. Very dense clayey sands with gravel were also encountered in Boring EB-1 from about 17 feet until the terminal depth of the boring at 24½ feet; EB-3 from 11½ feet to 17½ feet and again from 42 feet until the end of the boring at 49½ feet; and EB-4 from 16 feet to 24 feet. Geologic cross sections depicting the subsurface conditions in the Memory Care facility area are presented on Figures 7A and 7B.

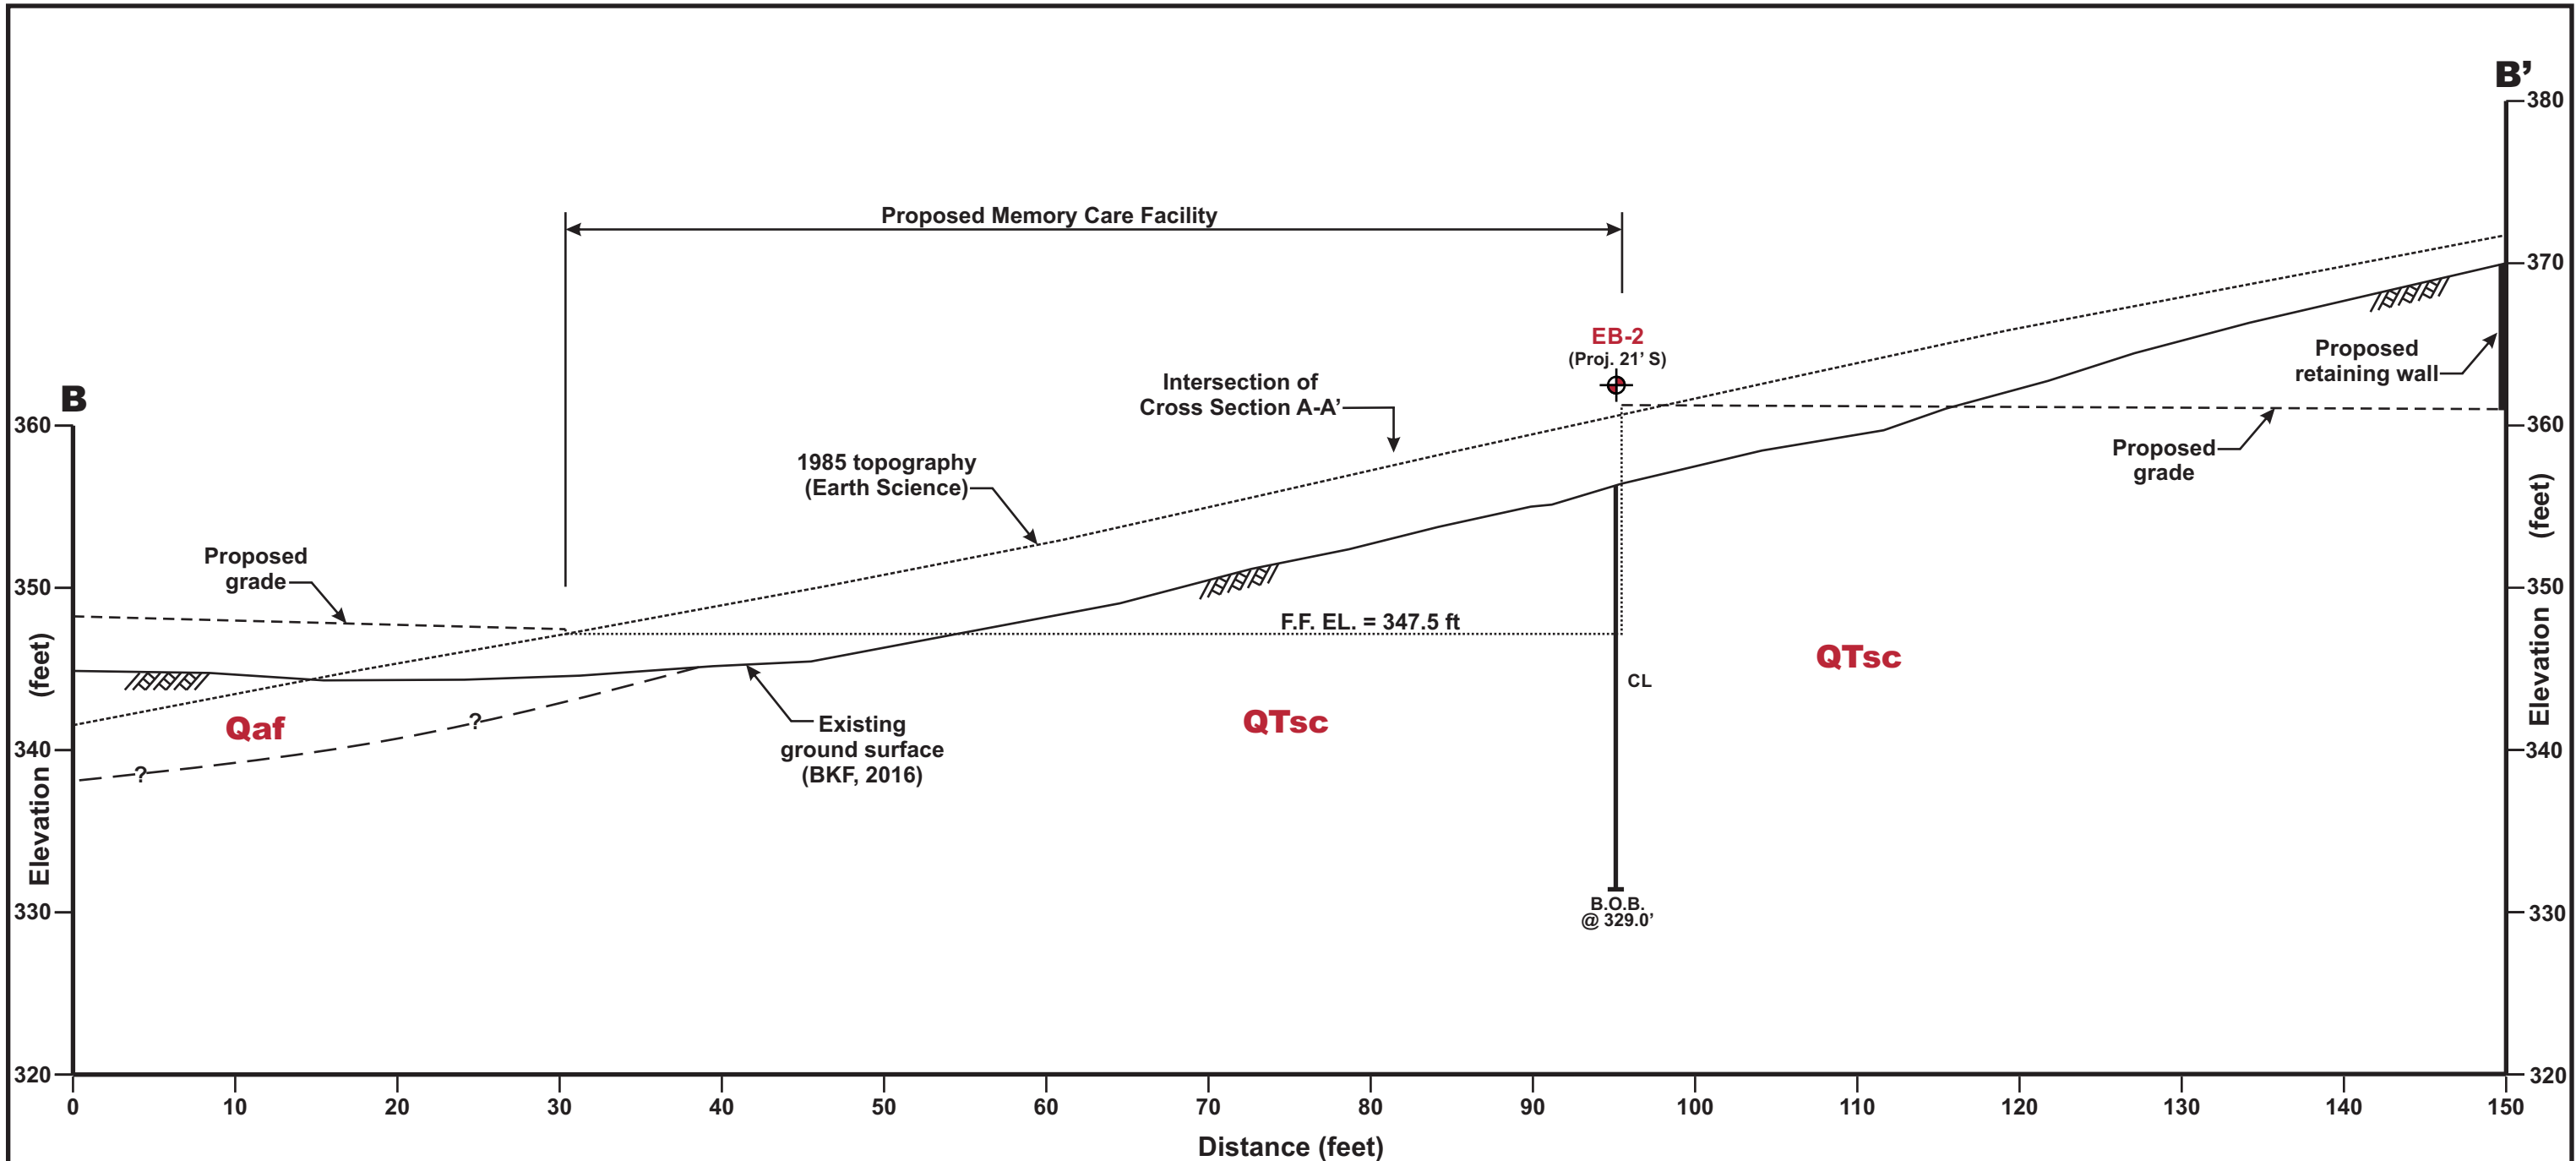
CORNERSTONE EARTH GROUP	Geologic Cross Section B-B' - Memory Care Facility		Project Number 905-1-1	
	The Forum at Rancho San Antonio Cupertino, CA		Figure Number Figure 7B	
			Date March 2017	Drawn By RRN

Section B-B'
 (View Looking North)
 1"=10' H:V

- Notes:
- 1) Surficial fills associated with existing pavements, landscaping or utilities are not shown.
 - 2) The subsurface profile is conceptual and is based on limited subsurface data obtained from widely spaced borings. Actual subsurface conditions may vary significantly between borings.
 - 3) See Figure 6A for location of cross section.

Geologic Units		Symbols	
QTsc	Santa Clara Formation (lower Pleistocene and upper Pliocene)	CL	Lean Clay or sandy clay
Qaf	Artificial (man-made) fill		Approximate location of exploratory boring (EB)

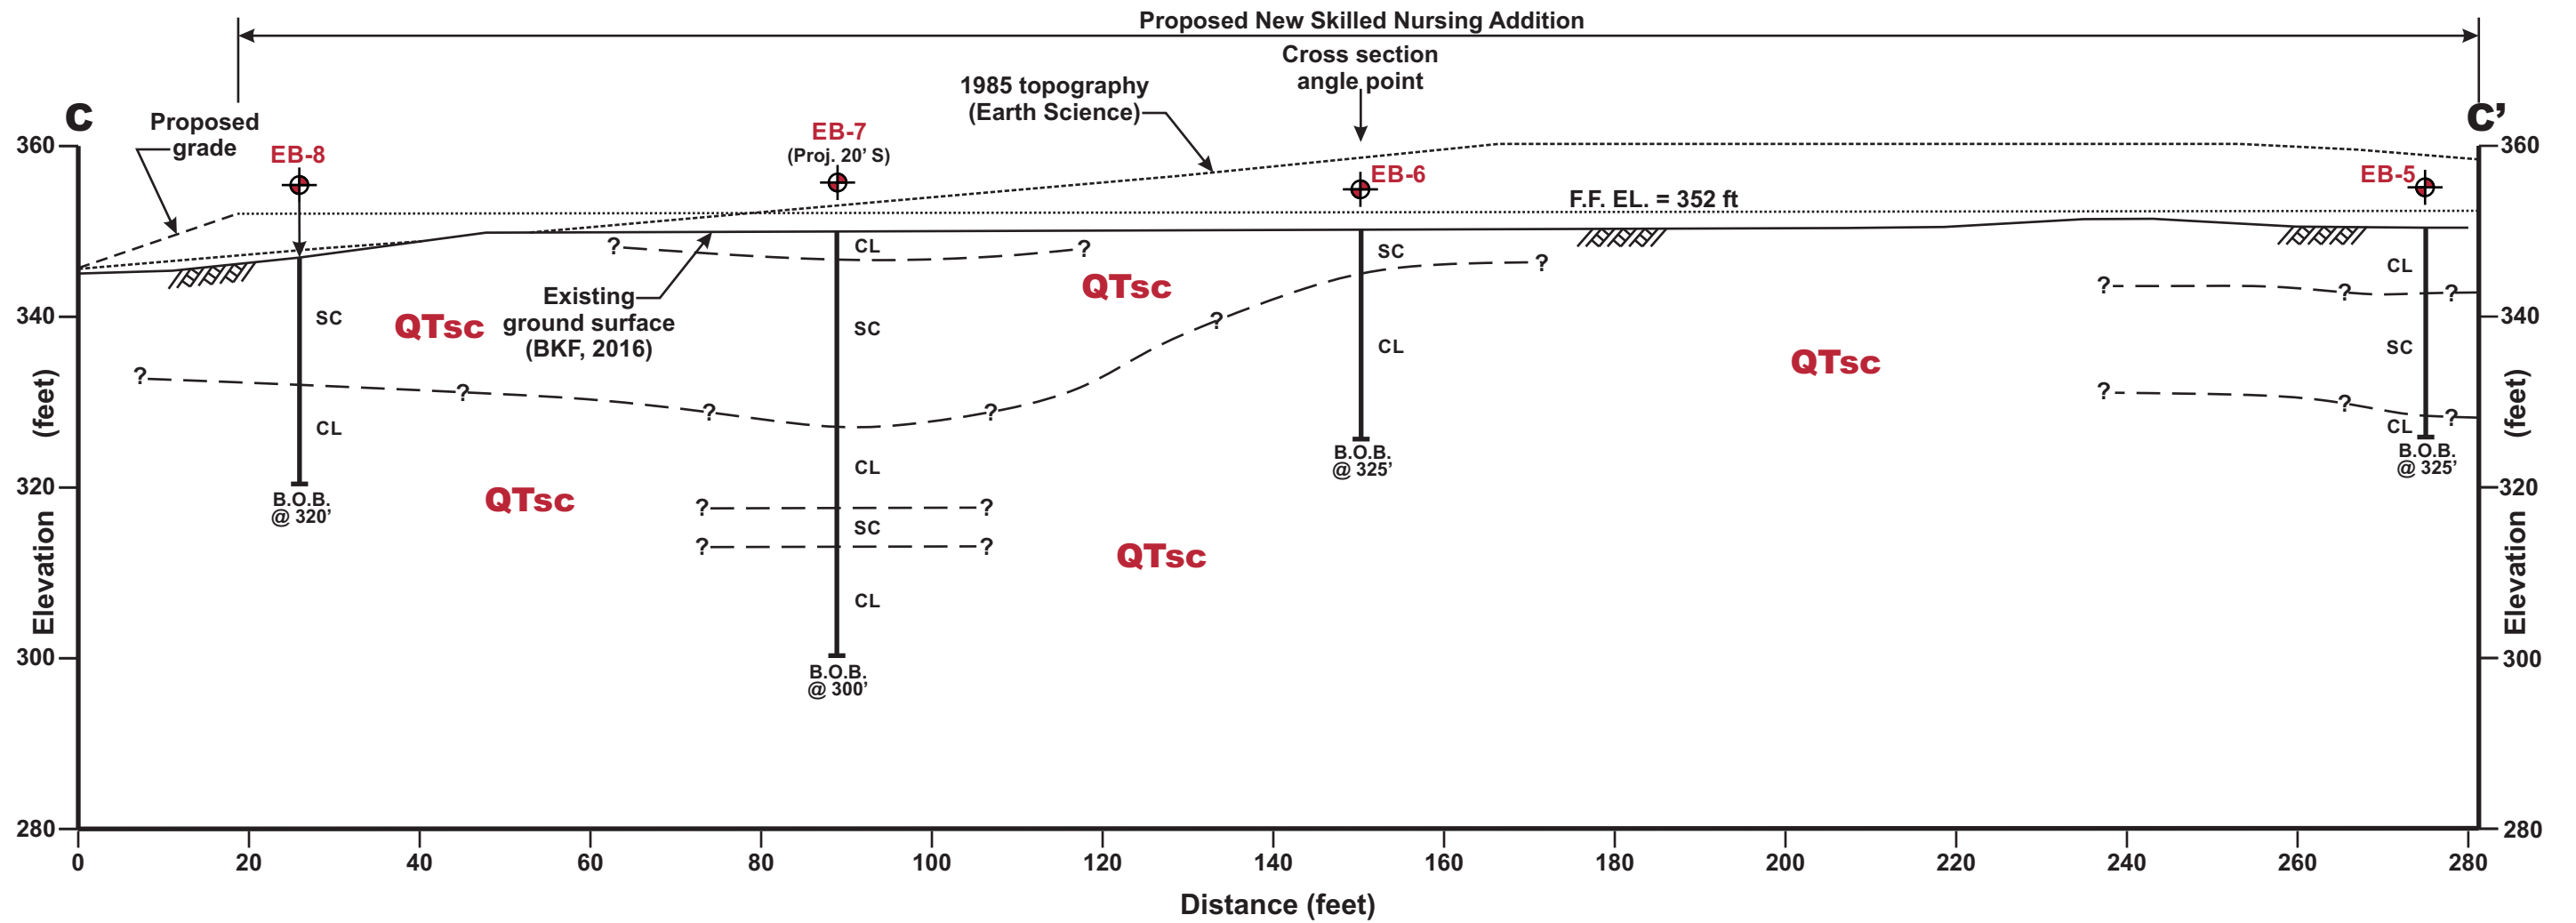
Project Number	905-1-1
Figure Number	Figure 7C
Date	March 2017
Drawn By	RRN

Section C-C'
(View Looking North)
1"=20' H:V

Based on conditions encountered in Borings EB-5 through EB-8 and EB-23, Santa Clara Formation materials were encountered immediately below the surface pavements or ground surface. Boring EB-23 encountered less than 12 inches of fill below the pavement consisting of hard sandy clay with gravel. Below the fill or in areas where no fill was encountered, the borings encountered Santa Clara Formation consisting primarily of medium dense to very dense clayey sand with gravel interbedded with very stiff to hard lean clays with sand and sandy lean clays. A general summary of the soil types encountered within the Skilled Nursing Facility footprint are summarized in the following table. Geologic cross sections depicting the subsurface conditions across the skilled nursing facility addition area are presented on Figures 7C and 7D.

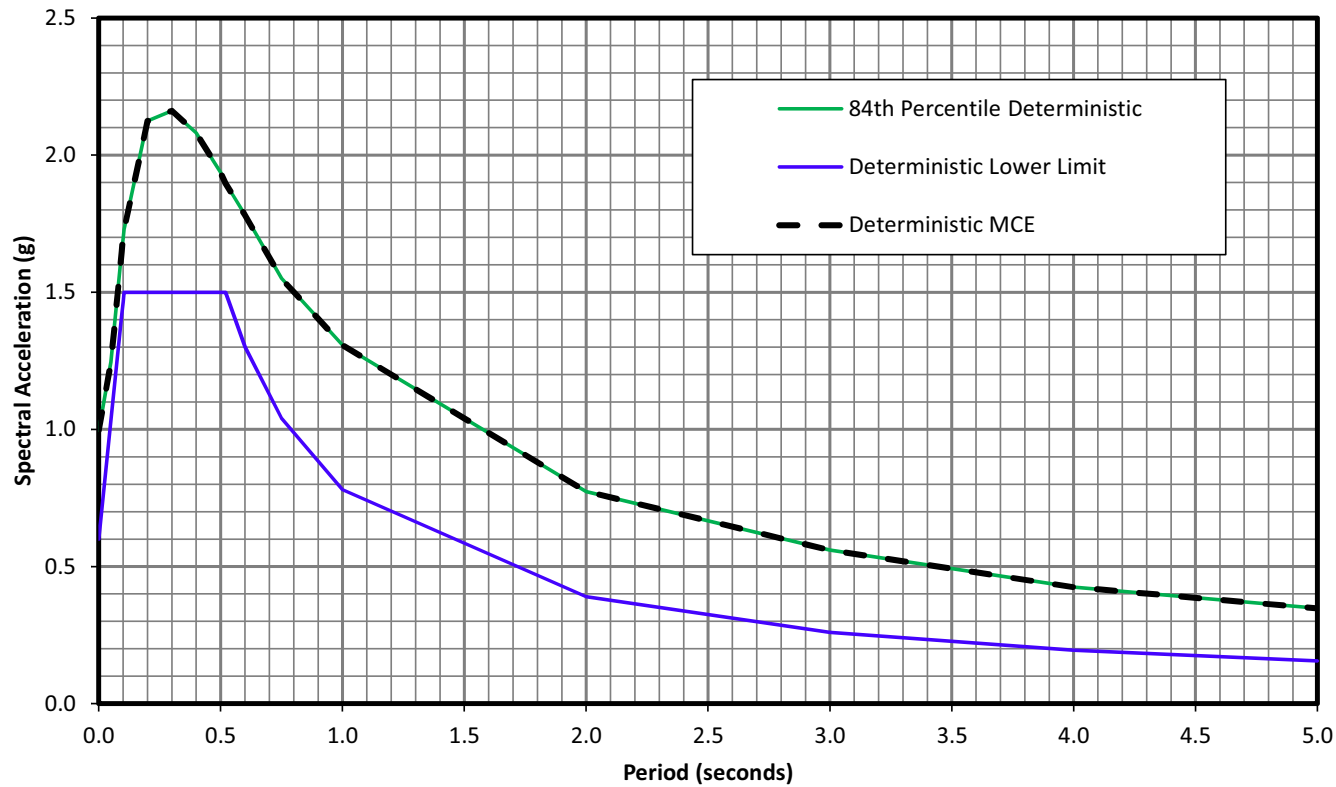
The Deterministic Maximum Considered Earthquake (MCE_R) is defined as the greater of the following at all periods:

- The largest 84th percentile ground motion from a characteristic earthquake on all known active faults, or
- The Deterministic Lower Limit MCE Spectrum – ASCE 7–10, Figure 21.2–1.

ASCE 7-10 specifies that the deterministic MCE_R shall not be less than the Deterministic Lower Limit MCE response spectrum (ASCE 7-10 Figure 21.2-1). The Deterministic Lower Limit spectrum is presented on Figure E1 (blue line). Spectral ordinates are tabulated in Table E2, Column 4.
