GEOTECHNICAL FEASIBILITY INVESTIGATION

Vallco Special Area Specific Plan Cupertino, California

SUBJECT : **Geologic and Geotechnical Feasibility Evaluation**
RE : Vallco Special Area Specific Plan
Proposed Multi-Use Development
Wolfe Road and Vallco Parkway, Cupertino

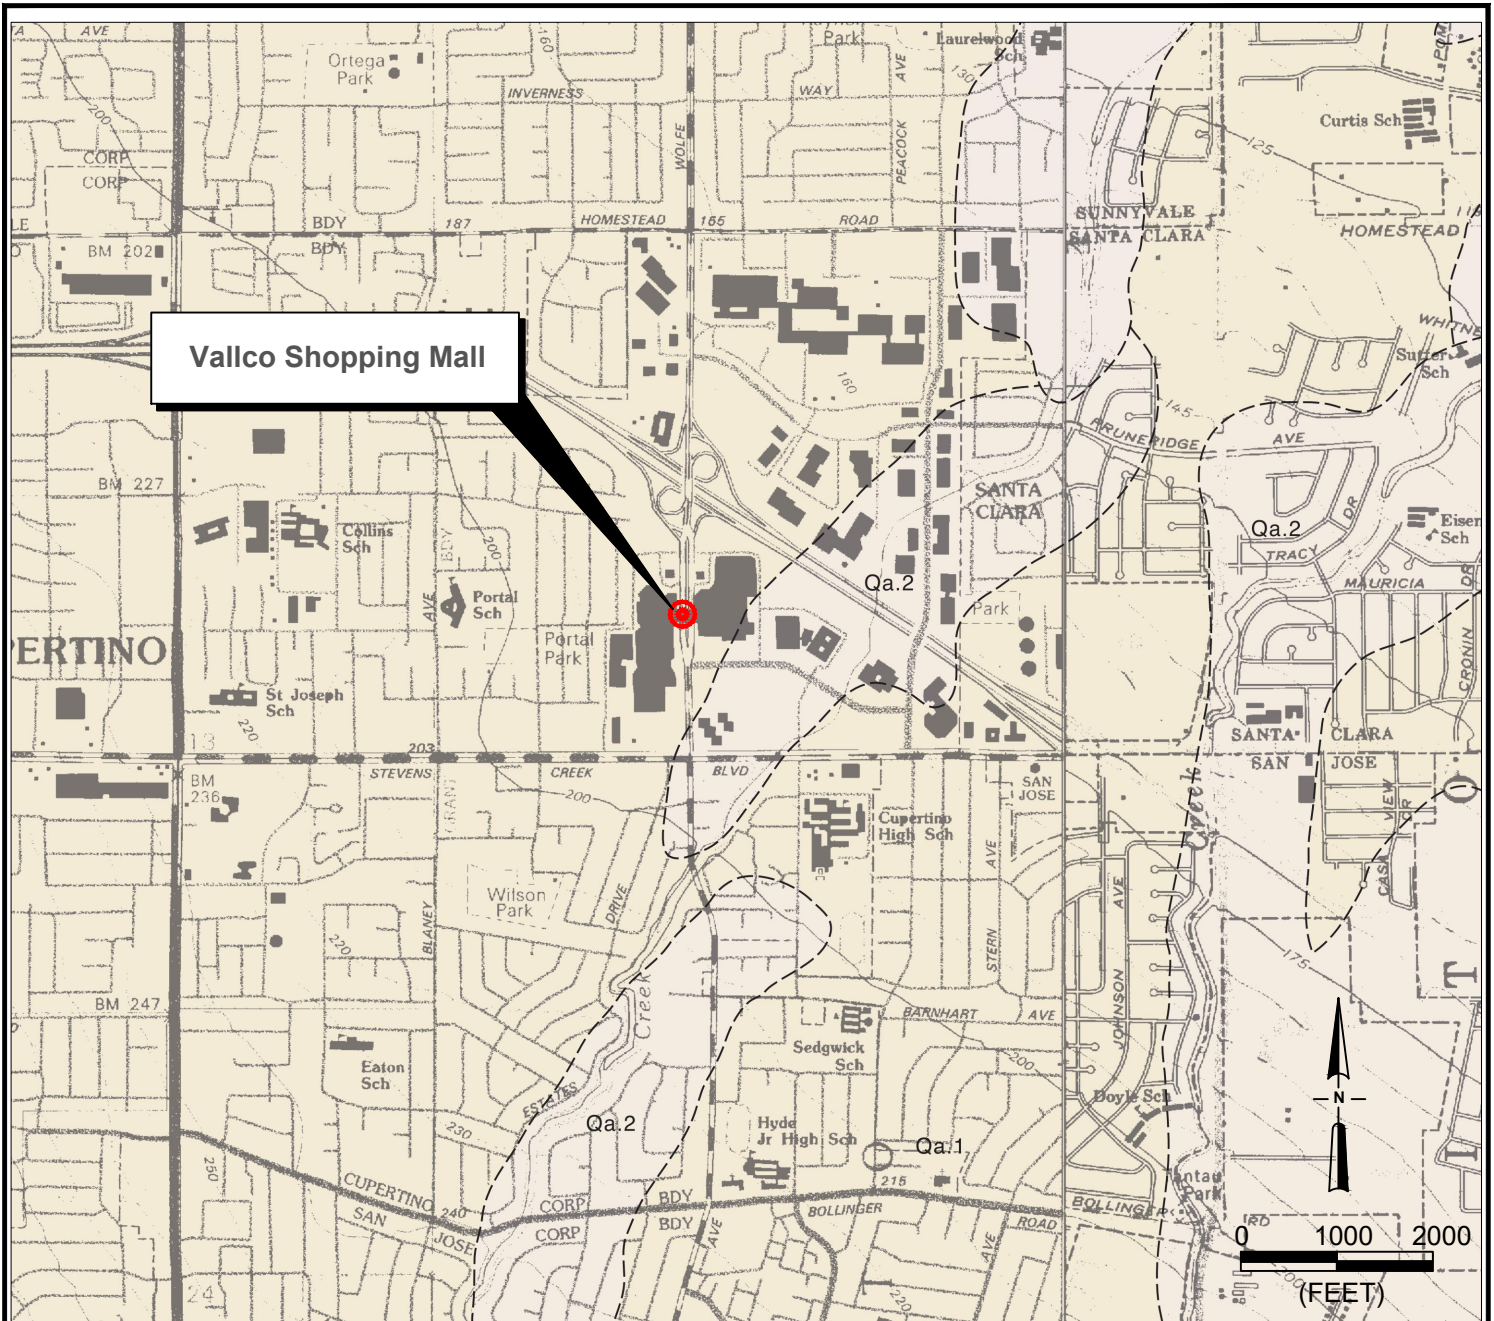
GEO/ENG BY RR	SCALE 1"=2000'	PROJECT NO. G5035
APPROVED BY JW	DATE MARCH 2018	FIGURE NO. 3

Reference: Geologic Map of the Cupertino and San Jose West Quadrangles, Thomas W. Dibblee, Jr. 2007

- Qa. 1 Alluvial sand, fine-grained, silt, and gravel; where differentiated represents alluvial fan deposits at base of slope and upper fan areas; mapped as part of undivided Qa where not differentiated
- Qa. 2 Alluvial gravel, sand, silt and clay; represents younger stream alluvium in fan deposits; mapped as part of undivided Qa where not differentiated

GEOLOGIC MAP
Geotechnical Feasibility Investigation
Vallco Special Area Specific Plan
Cupertino, California

2.2 Geologic Setting – The project site is located within the Coast Range Geomorphic Province. Local uplift of the Santa Cruz Mountains within the last 2 to 3 million years has occurred due to a restraining bend of the San Andreas fault, producing transpressional forces across the plate boundary. Thrust faults bound the San Andreas fault, and are responsible for uplift of the range. The range is characterized by rugged hills with moderate relief, steep valleys, and locally steep hillsides abutting drainages. East-flowing drainages result in dissection of the mountain range and alluvial deposition within the San Francisco Bay structural trough. According to published geologic maps (Dibblee, 2007), the site is underlain by unconsolidated older alluvial sediments (Figure 2, Regional Geologic Map). Young bay margin alluvium is locally susceptible to settlement and liquefaction; however these sediments are approximately 7 miles from the site. In the 1948 aerial photographs, the project site was an orchard. By 1970, the majority of the site was still an orchard; however, a large building was in place at the northwest corner of Stevens Creek Boulevard and Wolfe Road.

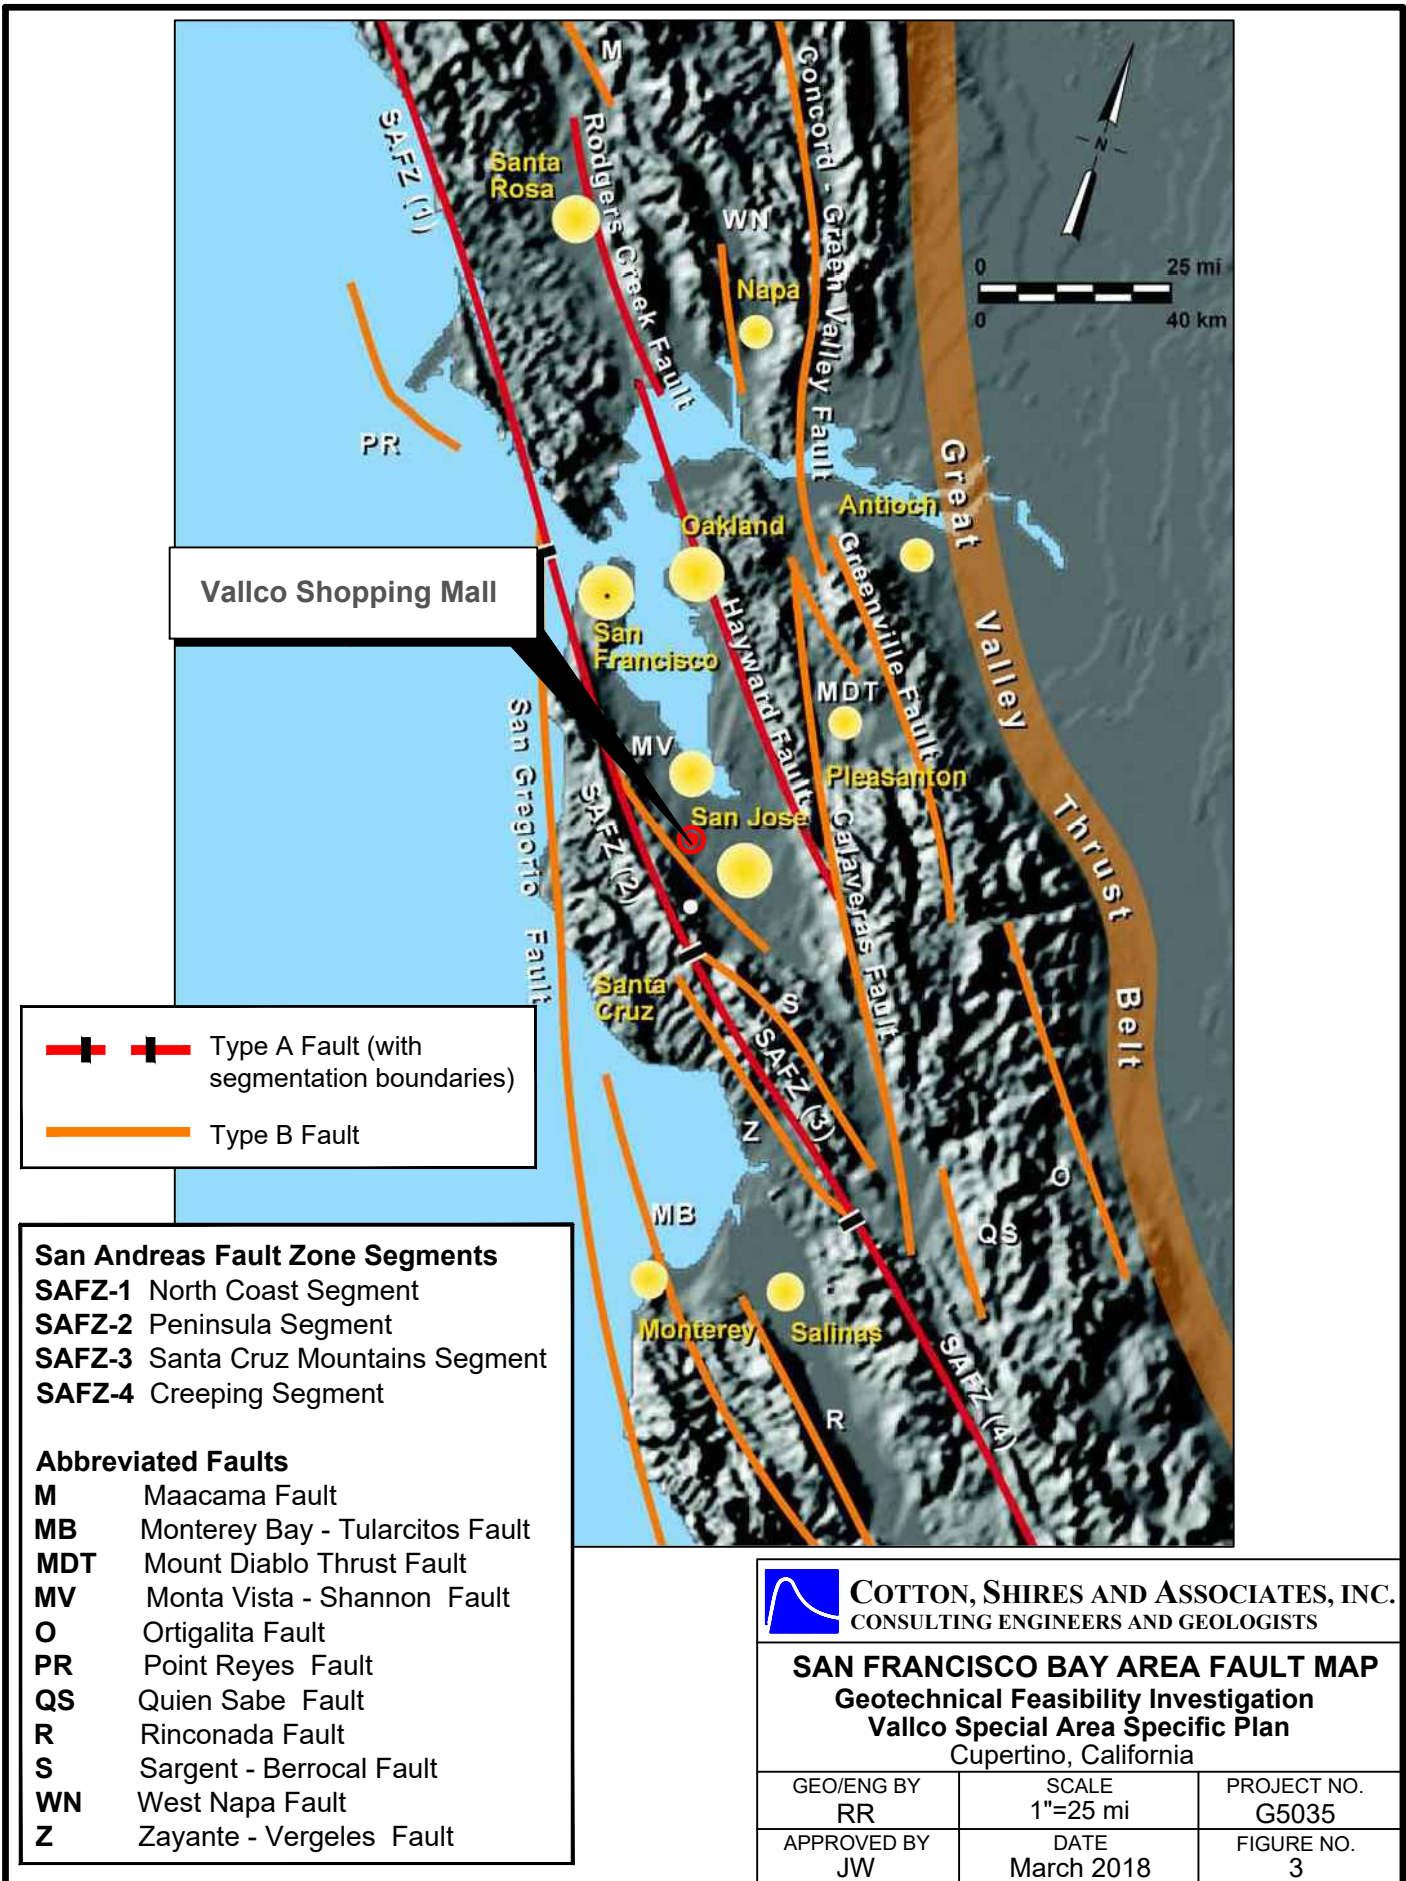
2.3 Seismic Setting - The project site is situated in a very seismically active area. Historically, this area has been subjected to very strong ground shaking from major earthquakes and the site will continue to experience very strong ground shaking in the future. Figure 3 illustrates the significant active faults located closest to the site, including the San Andreas fault zone (located 6.3 miles toward the southwest), the Hayward fault (located 12 miles to the northeast), the Sargent/Berrocal fault (located 5.2 miles toward the southwest), and the Monta Vista/Shannon fault (2.7 miles to the southwest). The site is not located within a State (California Geological Survey) Mapped Alquist-Priolo fault zone, or an Earthquake-Induced Landslide or Liquefaction Hazard Zone.

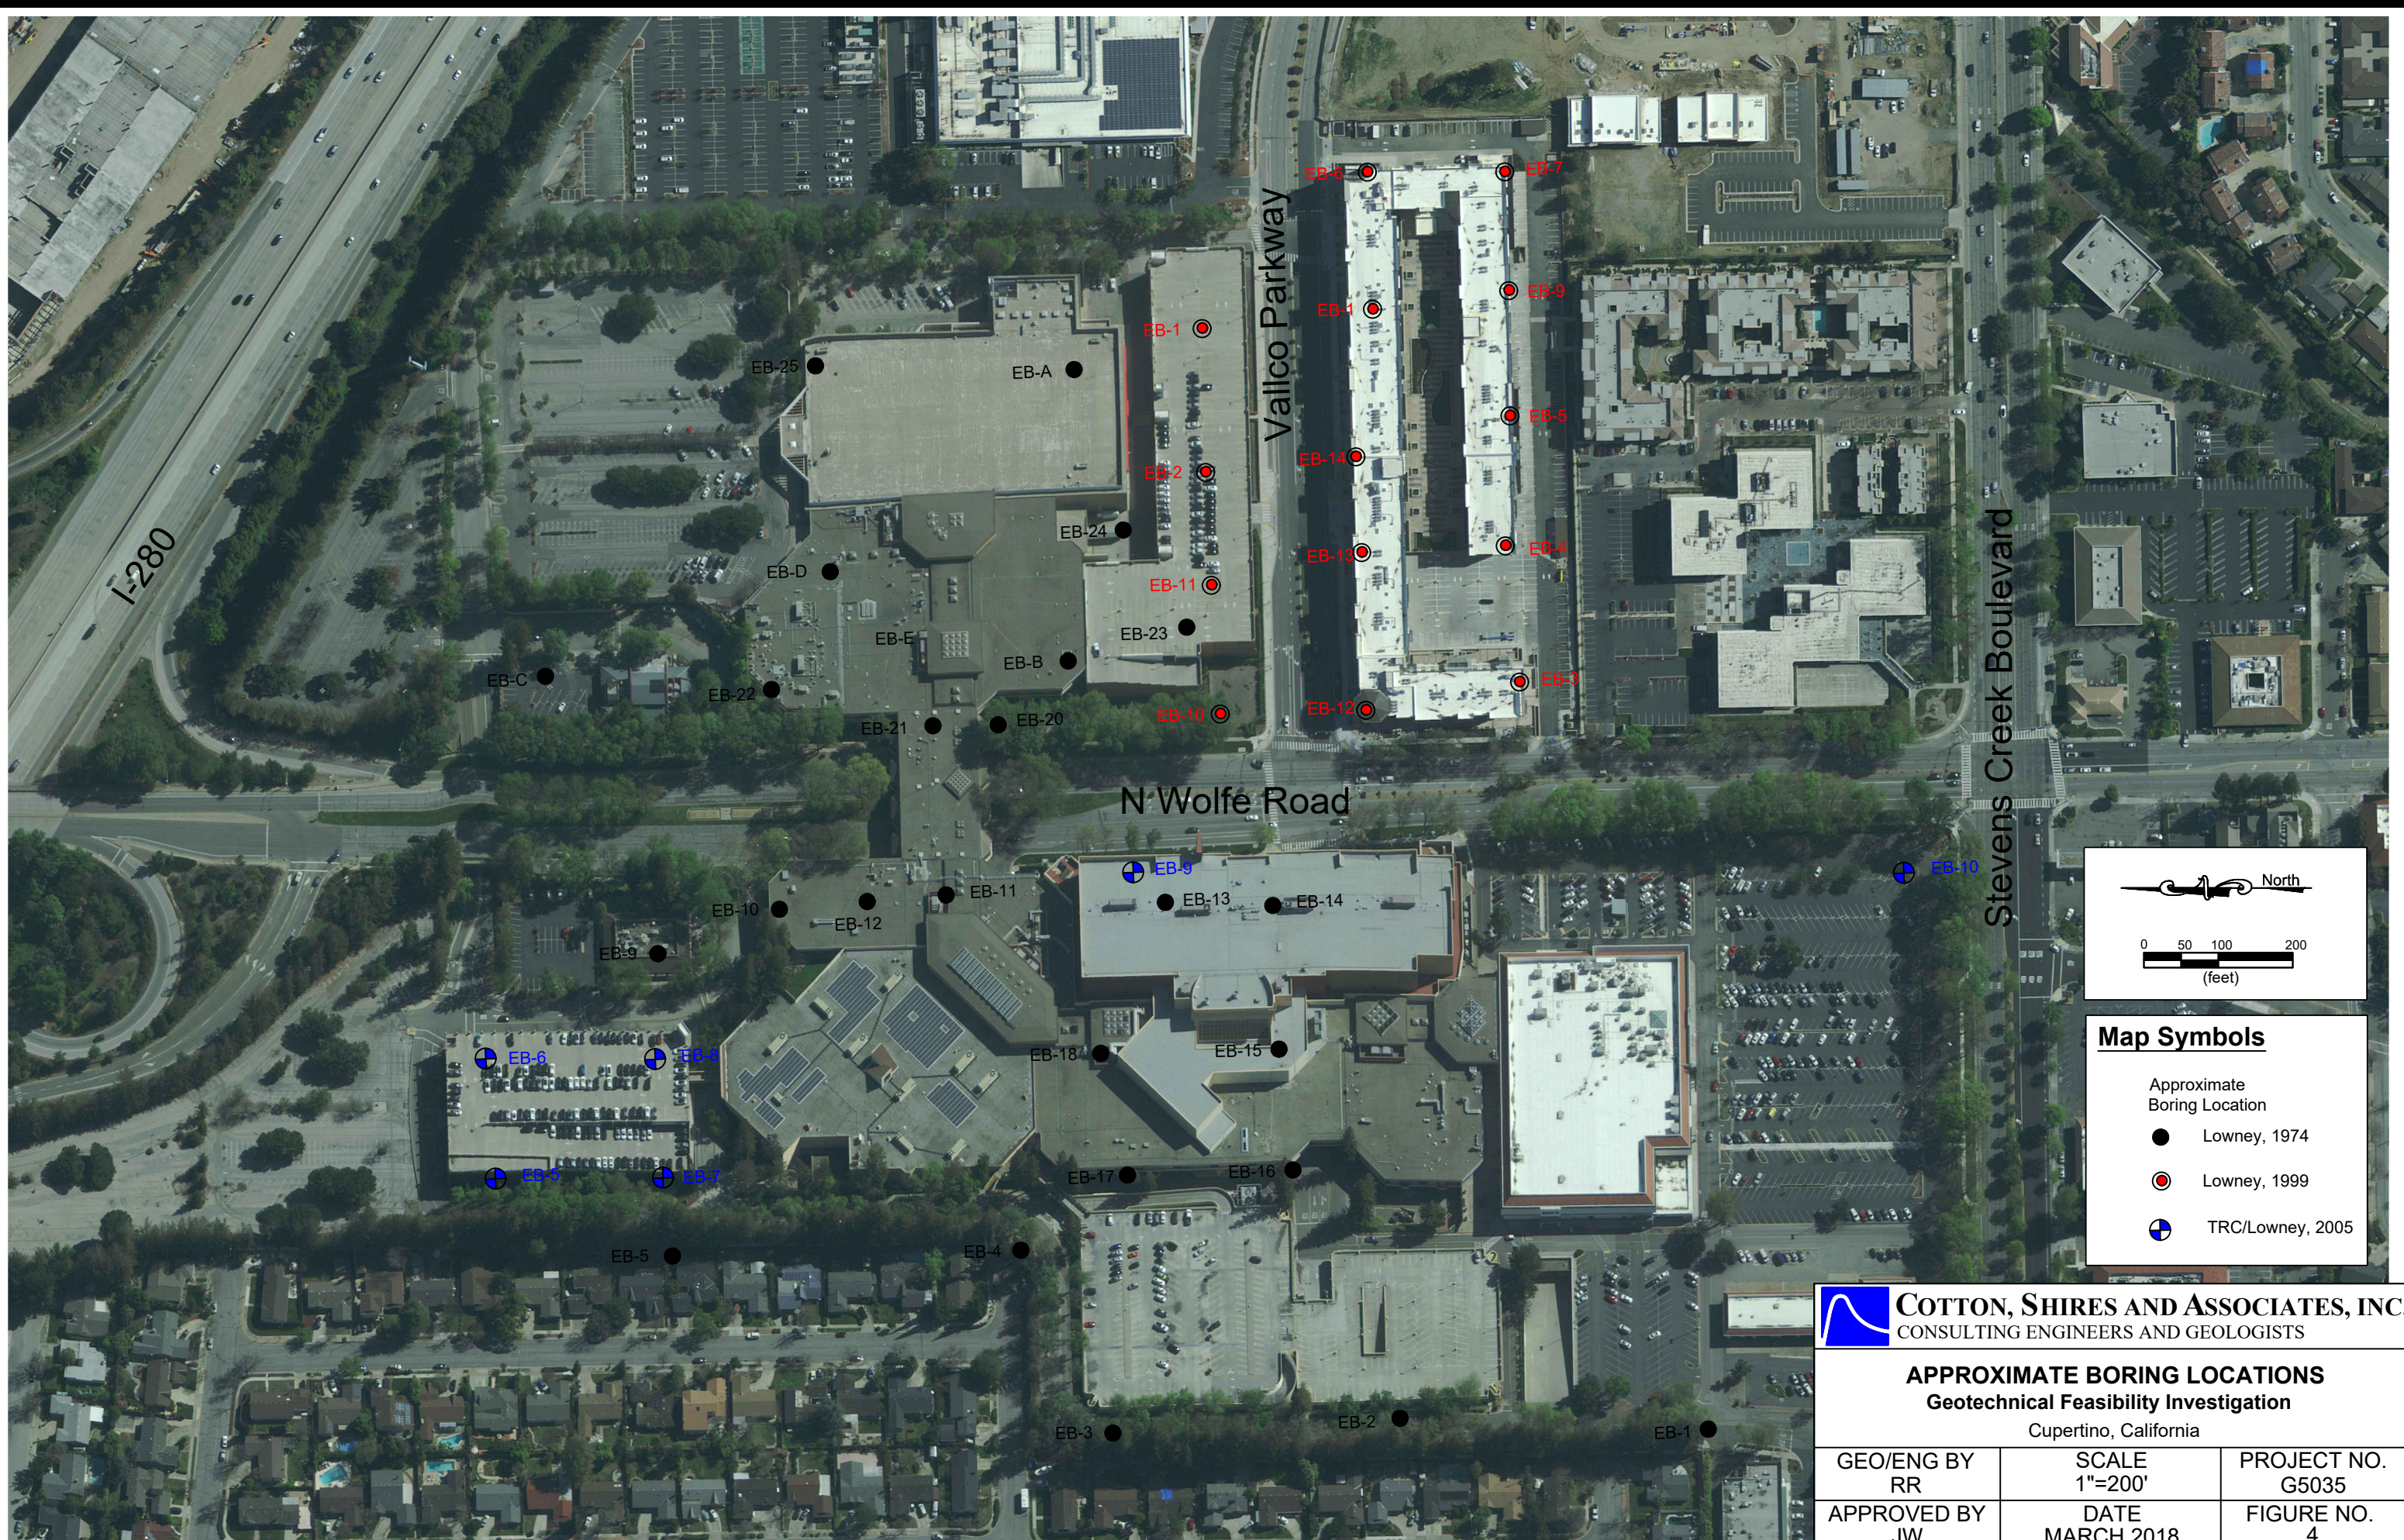
GEO/ENG BY RR	SCALE 1"=200'	PROJECT NO. G5035
APPROVED BY JW	DATE MARCH 2018	FIGURE NO. 4

- Approximate Boring Location
- Lowney, 1974
- Lowney, 1999
- TRC/Lowney, 2005

APPROXIMATE BORING LOCATIONS
 Geotechnical Feasibility Investigation
 Cupertino, California

3.2 Subsurface Conditions – The site of the proposed Vallco re-development has been the site of multiple past geotechnical investigations, where subsurface exploration was performed. As a result, no subsurface exploration was performed by CSA as part of this Feasibility Investigation. Prior investigations included small-diameter exploration in 2005 (TRC Lowney), 1999 (Lowney Associates), 1974 (Lowney-Kaldveer), and 1972 (Lowney Kaldveer). The boring locations have been illustrated on Figure 4 (Boring Location Map); however, the locations should be considered approximate since we have estimated the locations based upon maps generated by others. We also reviewed the results of exploratory borings drilled in 2007 for the Main Street development on the adjacent parcel to the east. The subsurface exploration spanning 1972 to 2005 encountered similar earth materials, including typical alluvial fan deposits consisting of interbedded gravel, sand, silt and clay. The upper 5 to 8 feet typically included loose sand and soft clays with blow counts in the N=5 to N=15 range in the 1970s. The more recent boring logs reveal that the upper 5 to 10 feet of the site encountered mostly stiff to hard clays, and dense sands. We

interpret this difference between the older investigations and the newer investigations to be the result of the Vallco development where excavation/compaction of the loose upper soils was performed. The recent borings reveal that, in general, the site is underlain by medium dense to dense sands, and stiff to hard clays.
